Strata Property Act
SECTION 59 (Form B) INFORMATION CERTIFICATE

Strata BCS 1265 Bel Air Depreciation Report

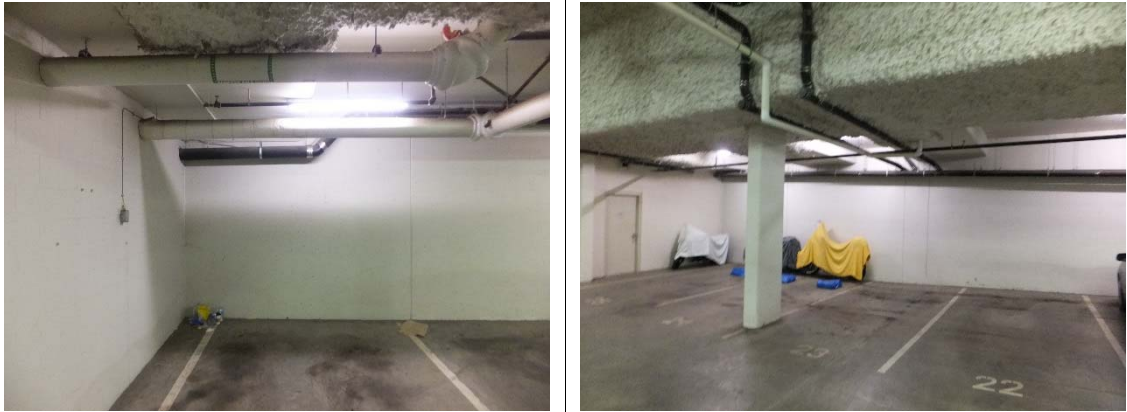
S 1 – Foundation & Structure		
Year Installed	2005	Description: The main structure of the building consists of cast-in-place concrete framing including columns, beams and suspended floor slabs. The interior walls have steel studs. The structure is supported on a reinforced cast-in-place concrete foundation. The parkade is primarily located below the footprint of the building. The perimeter foundation walls are likely protected with a damp-proofing or waterproofing membrane to mitigate water ingress. The footings are likely cast-in-place strip footings at foundation walls and concrete pad footings at columns. The flooring at the lowest level of the parkade consists of a reinforced concrete slab on grade with catch basins for drainage.
Expected Life Span	80+	
Observed Condition	8	
Repair or Replace	10

<p>Visual Review: The concrete-framed structure of the building is typically concealed by exterior coatings and interior finishes. Portions of the foundation walls that extended above grade appeared to be protected with a damp-proofing or waterproofing membrane. The interior side of the foundation walls, viewed from within the parkade, are painted white and parking space numbers and lines are painted on the surface of the slab-on-grade. From the interior of the parkade, where checked, we did not note any serious cracking or other areas of concern beyond typical settling and one small isolated section in a stairwell that was pointed out to us by a Strata council member which will likely be addressed under general building maintenance.</p>		
<p>Recommendations: The foundation and structure can deteriorate due to several factors such as hydrostatic pressure, seismic activity, or water infiltration through the cracks in foundation walls and exterior wall cladding, as well as typical building settlement. Foundation walls located below grade are susceptible to leaks if cracks form along the walls allowing moisture to penetrate into the parkade area. Structural components typically last the life of the building, so full replacements have not been considered in this Report. However, there is potential for failure of some of the waterproofing.</p> <p>To mitigate water penetration, in the plan we have included an allowance for isolated concrete repairs to perimeter foundation walls below grade, starting in the year 2023 and every 20 years thereafter. Typically these repairs include the injection of waterproofing materials into cracks along the concrete foundation walls as well as concrete repairs.</p>

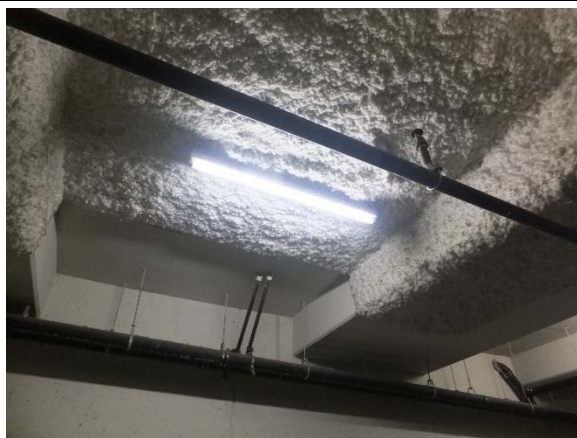
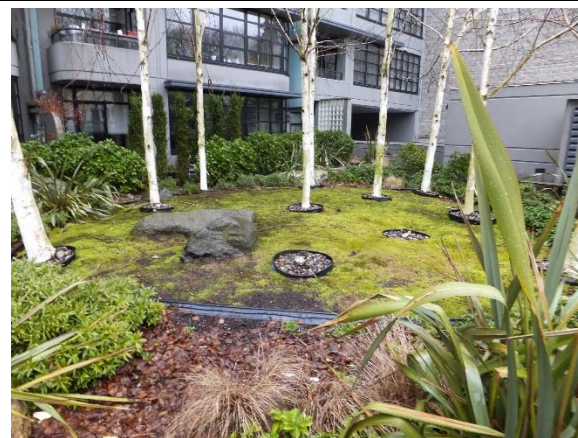
S 2 — Parkade Roof Deck

Year Installed	2005	Description: There is a single storey parking garage located below the footprint of the building. The parkade has a reinforced suspended concrete roof slab that supports the above grade concrete superstructure of the building. Portions of the roof slab, extend beyond the exterior wall framing of the building creating a buried roof deck that is protected with a waterproofing membrane below hard and soft landscaping materials. Drainage at the suspended slabs is accomplished with internal bi-level roof drains.
Expected Life Span	20-30	
Observed Condition	8	
Repair or Replace	17 & 22

Visual Review: The condition and visual review of the membrane of the buried parkade roof deck could not be determined due to the presence of overburden materials and landscaping. Our review was limited to the soffit (underside) of the suspended roof slab from within the parkade.

There were no noted areas of excessive cracking or active leaking through the foundation walls or soffit of the roof slab, where checked.

Recommendations: The reinforced concrete structure of the parkade is susceptible to typical deterioration that might be quickened due to prolonged exposure to excessive moisture and/or de-icing salts. If these substances come in contact with the reinforcing steel within the slabs it can potentially lead to oxidization of the steel and detachment from the concrete surrounding it. Periodic concrete repairs and replacement of the membrane on the surface of the roof deck are required to keep the structure protected.

We have included costs for re-waterproofing the buried roof deck including removal and replacement of the overburden materials in the year 2035 on a 25 year cycle. The plan also allows for isolated repair projects to address water ingress through the garage roof deck slab to occur on a 25 year cycle starting in 17 years. The repairs should involve removal and replacement of isolated areas of the waterproofing membrane on the garage roof deck, concrete repairs and routing and sealing of cracks in areas of concern where leakage may be evident. Periodic injection of waterproofing material into leaking cracks at the soffit of the exposed parkade roof deck can also be completed to mitigate water infiltration. These injections may assist in deferring replacement of the waterproofing membrane, but are not a permanent solution. These injections have been excluded from the Report because they are assumed to occur on an as needed basis at a cost below the Report threshold and will therefore likely be funded from the annual operating budget.

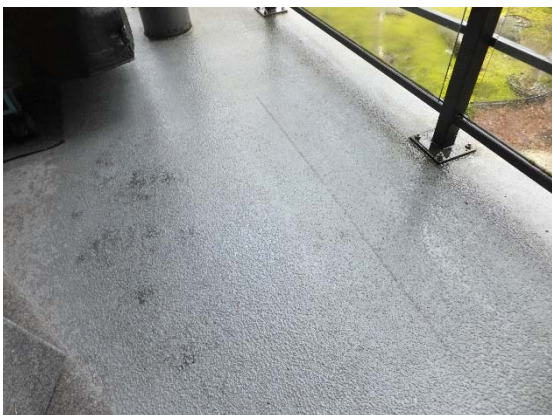
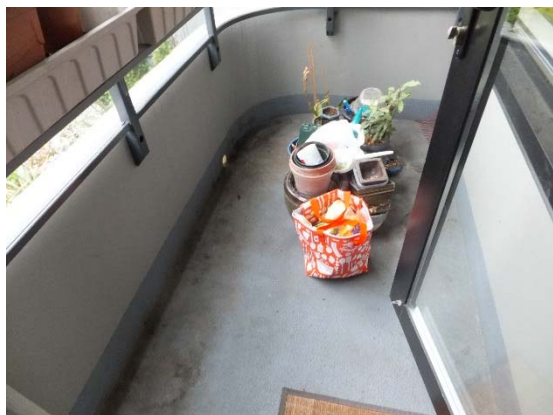
S 3 — Balconies		
Year Installed	2005	Description: Balcony assemblies consist of cantilevered extensions of the reinforced concrete floor slab that extend past the exterior walls. The top surfaces of the slabs are finished with an elastomeric membrane with a granular embedded top coat. The balcony slabs are sloped to the outer edges for drainage. The soffits and slab edges of the balconies are painted with an elastomeric paint finish.
Expected Life Span	20	
Observed Condition	8	
Repair or Replace	12	
<div style="display: flex; justify-content: space-around;">

</div>		
<p>Financial Review: We understand that the balconies are part of the original construction. We are not aware of any replacements or significant repairs to this component.</p>		
<p>Visual Review: We reviewed the balconies from grade, the roof level and the accessed suites and have assumed that all sections throughout the building are similar to the ones observed. We noted no significant cracking or deterioration of the membrane on the surface of the reviewed balconies, where checked.</p>

<p>Recommendations: Over time and with exposure to weather and Ultra-violet (UV) rays the elastomeric membrane coating the surface of the balcony floors will start to deteriorate and fail. Cracks may also form along the concrete allowing for moisture ingress resulting in deterioration of the concrete similar to that described in the sections S1 and S2 of this report.</p> <p>The plan allows reapplication of the balcony surface coat plus allowances for localized repair to the concrete balcony slabs to occur every 20 years with the first occurrence starting in the year 2025. The repair costs also include allowances for concrete repairs, routing and sealing of cracks and installation of a new elastomeric waterproofing membrane.</p> <p>We recommend that the Strata perform annual inspections of the balconies to monitor their condition and ensure that there are no safety concerns.</p>

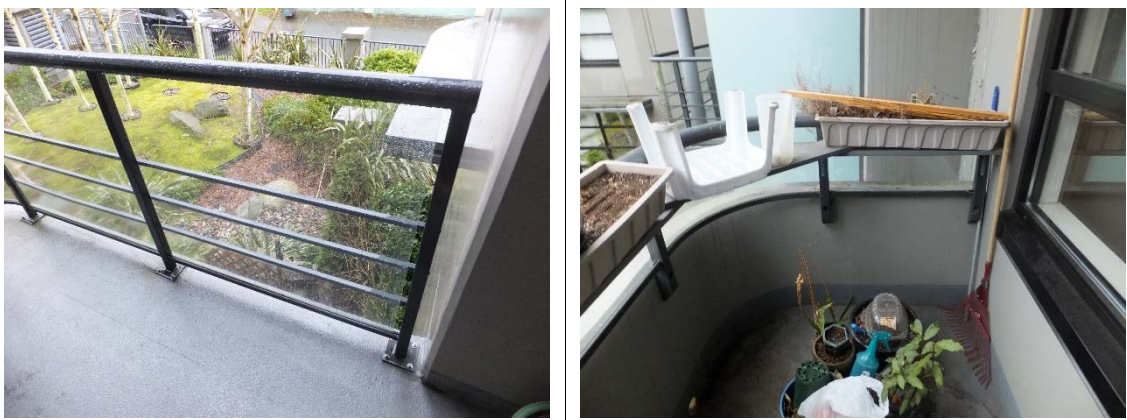
S 4 – Balcony Guards		
Year Installed	2005	Description: The balconies have two different guard styles. One type is a full height, surface-mounted metal post and handrail assembly with safety glass inserts and the other type consists of shorter, side-mounted metal assemblies attached to concrete pony walls.
Expected Life Span	20-30	
Observed Condition	8	
Repair or Replace	12

<p>Financial Review: We understand that the balcony guards are part of the original construction. We are not aware of any replacements or significant repairs to this component.</p>		
<p>Visual Review: We reviewed the balconies from grade, the roof level and the accessed suites and have assumed that all sections throughout the building are similar to the ones observed.</p> <p>We only performed a visual review of the assemblies and did not perform any physical testing as it was not in our scope. Where checked, guards appeared to be intact and secured.</p>

<p>Recommendations: Aluminum guard assemblies have a typical life expectancy of 20-30 years. Some guards wear quicker than others due to a number of potential factors such as different exposures to external elements and fluctuating wear-and-tear based on different uses.</p> <p>The plan allows for removal and replacement of approximately 50% of the aluminum guards to occur in correspondence with every balcony repair project. The first instance of the guard replacement is planned to commence in the year 2025 and then every 20 years thereafter.</p> <p>We recommend that along with the annual inspection of the balcony assemblies the Strata take note and monitor the condition of the guards as well.</p>

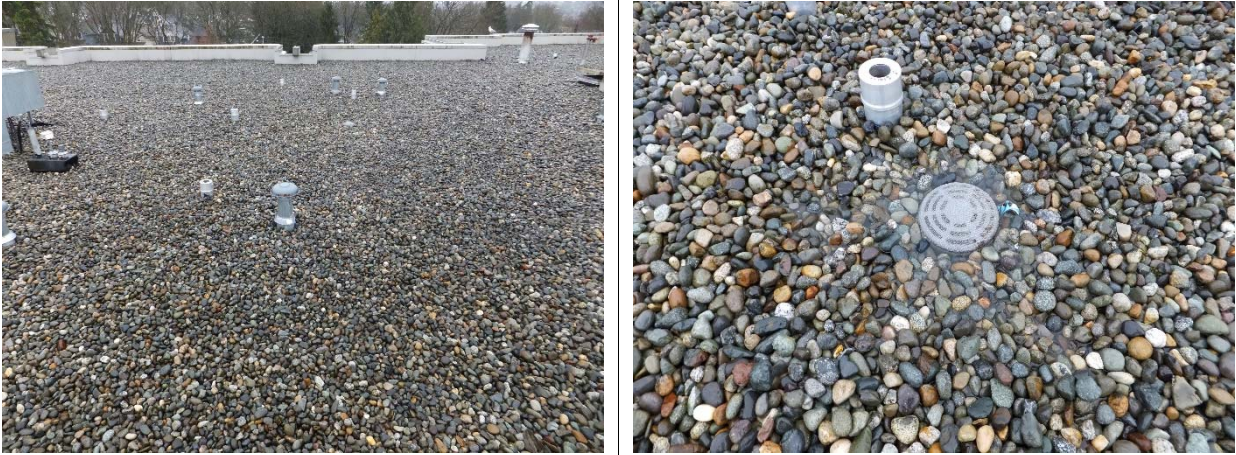
EE 1 – Flat Roofing		
Year Installed	2005	Description: The flat roof is comprised of an inverted roof membrane which according to the building plans has gravel ballast, 2-ply waterproofing membrane, rigid insulation, and protection board all atop the sloped concrete roof slab. Drainage is accomplished at all roof areas via internal roof drains with metal grate covers and overflow scuppers along the perimeter parapet walls. Prefinished metal flashing is installed at roof perimeters and upturns.
Expected Life Span	20-25	
Observed Condition	8	
Repair or Replace	15

<p>Financial Review: We understand that the flat roofing is part of the original construction. We are not aware of any replacements or significant repairs to this component although our review of the Strata documents detailed a few minor repair projects that have occurred sporadically since the building's construction.</p>		
<p>Visual Review: As stated in the description, our understanding of the roofing materials used is based heavily on the information provided by the building plans. We did not perform any tests to confirm the layers of roofing materials beneath the overburden gravel ballast. Where observed, we did not note any obvious signs of blistering or ridging along the parapet walls and there were no obvious signs of pooling or obvious damage along the flat sections.</p>

<p>Recommendations: Flat roofing with inverted membranes have a typical life expectancy of 20 to 25 years. Failure of these assemblies can occur due to many factors such as poor installation, excessive ponding, or loss and/or movement of gravel ballast exposing the membrane to external elements like UV rays.</p> <p>The plan allows for replacement of the flat roof area in 15 years on a 20 year cycle. Additionally, we recommend the Strata perform or have a roofing contractor perform periodic, perhaps annual, inspections of all roofing types and complete any necessary maintenance and repairs to mitigate premature failures.</p>

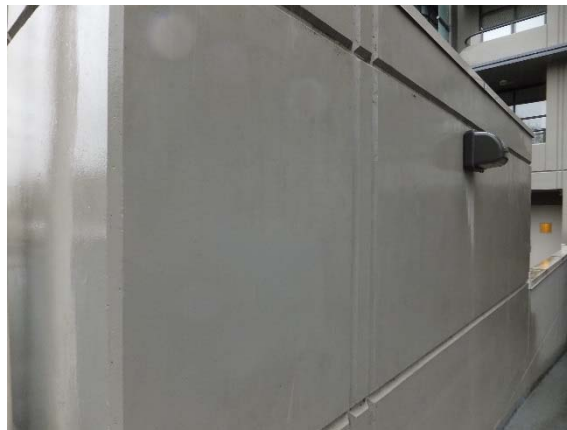
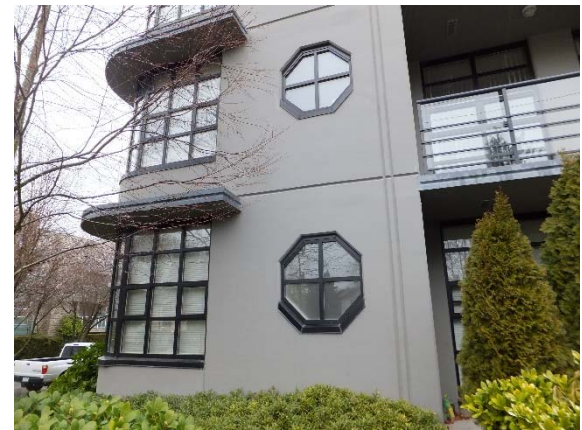
Year Installed	2005	Description: According to the building plans provided, exterior walls consist of cast-in-place concrete walls with paint applied throughout with sealants adhered around doors and windows and at transitional joints.
Expected Life Span	10-12	
Observed Condition	8	
Repair or Replace	4

Visual Review: From our visual review, from grade and the accessed balconies, there did not appear to be any obvious signs of deterioration or delamination of the concrete along the exterior surface of the walls, where checked.

Recommendations: Regular wall maintenance including cleaning and sealing will generally assist in mitigating premature deterioration and failure of the exterior cladding concrete walls. The coating will assist in mitigating water penetration at the exterior walls. Over time with weathering and aging the coating and sealants will begin to crack and break down requiring eventual replacement.

The plan allows for recoating the walls and replacement of the sealants to occur in 4 years and then every 12 years thereafter.

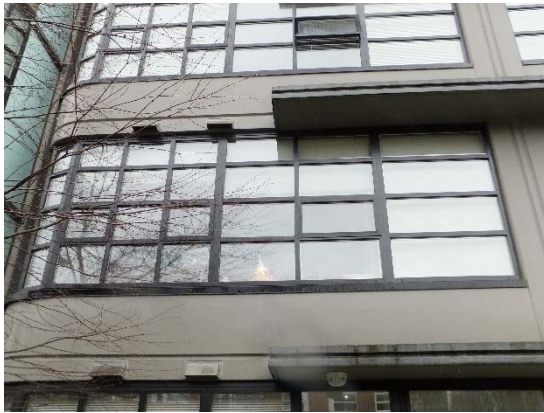
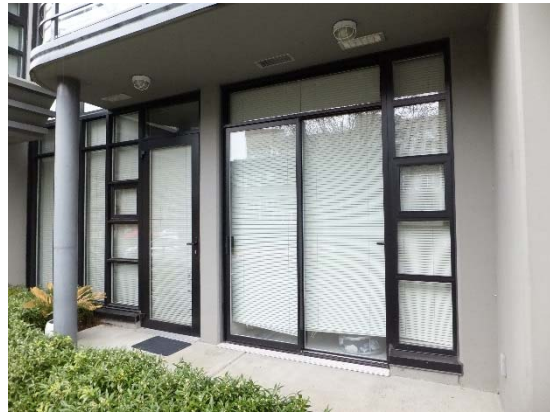
EE 3 — Windows & Balcony Doors		
Year Installed	2005	Description: The windows and balcony entry doors both consist of double-glazed aluminum-framed units. There are an assortment of fixed and operable style window assemblies along with sliding and pivoting door assemblies. Window units are typically inset within the concrete walls with metal flashing at the head and foot of each window unit. Weep holes are provided at the base of the windows to allow for drainage. Window and door assemblies at the main entrances are discussed in the Exterior Doors section of this Report.
Expected Life Span	30-40	
Observed Condition	8	
Repair or Replace	27

Visual Review: From our visual review from grade and the accessed common areas we did not observe any major defects such as fogging or condensation between the glazing units. We did not conduct any performance tests on the operable window or door units but we have assumed that they are generally in good working condition based on the age of the building and the absence of any issues or complaints relayed to us.

Recommendations: Aluminum window frame assemblies typically have a life expectancy of 30-40 years. As the systems age and with exposure to the wet BC climate, seals may fail causing condensation and fogging between the glazing panes. Operable windows are susceptible to premature frame twisting as well as damaged or broken hardware and hinges. Over time the weather-stripping can become brittle and start to deteriorate.

We assume that periodic replacement of some windows will occur prior to full replacement of the window assemblies but they are assumed to be addressed on an as needed basis out of the operating budget. At the end of their expected life, the plan includes a replacement of the framed windows assemblies in 27 years and then every 35 years thereafter.

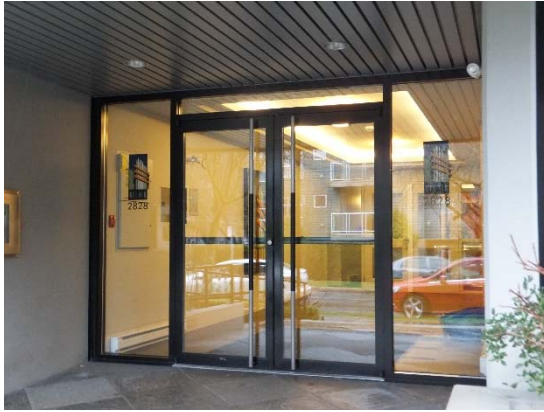
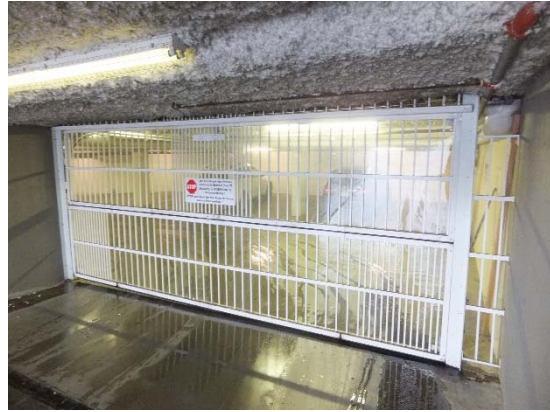
EE 4 – Exterior Doors		
Year Installed	2005	Description: The window and door assembly at the main entrance to the building consists of double-glazed aluminum-framed fixed window sections with an aluminum-framed glass door. Exterior service or secondary entrance doors are painted hollow core metal doors in metal frames. The garage is accessed by a prefinished aluminum sectional automatic overhead door.
Expected Life Span	20-30	
Observed Condition	8	
Repair or Replace	17

Visual Review: We are not aware of any performance issues with the exterior door assemblies. They are generally located in sheltered areas protecting them from most elements. Where checked, the doors operated smoothly.

Recommendations: Exterior doors of these types typically have a life expectancy of 20-30 years. Since the exterior doors at this property are generally sheltered we have assumed that replacement will be required in the later part of the life expectancy.

The plan allows for the replacement of the balcony entry doors to occur in 27 years on a 35 year cycle. Costs for their replacement are included in the Window Replacement project.

Replacement of the main entrance and overhead garage door is planned for in 17 years on a 25 year cycle.

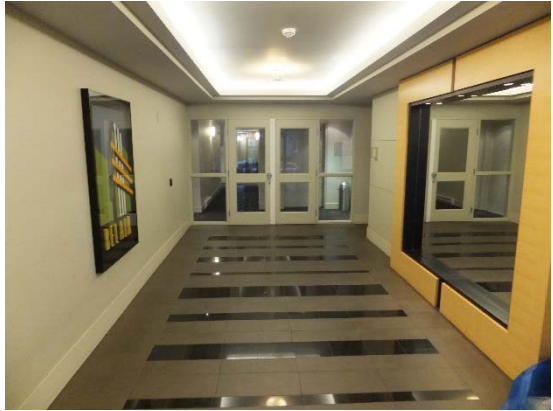
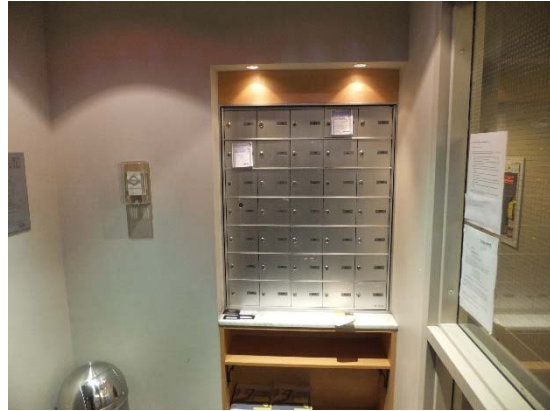
I 1 – Lobby		
Year Installed	2005	Description: The main entrance lobby of the building is finished with tile flooring along with painted drywall ceilings and walls. There is a decorative panel and mirror section to one side. Lighting is accomplished via various fixtures and there is a mailbox area located at the opposite end of the lobby from the main entrance.
Expected Life Span	15-25	
Observed Condition	8	
Repair or Replace	4 & 13

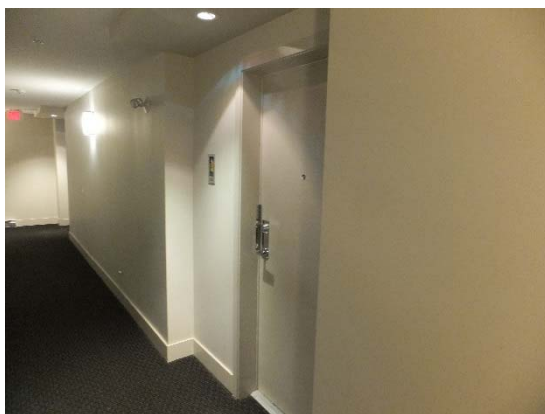
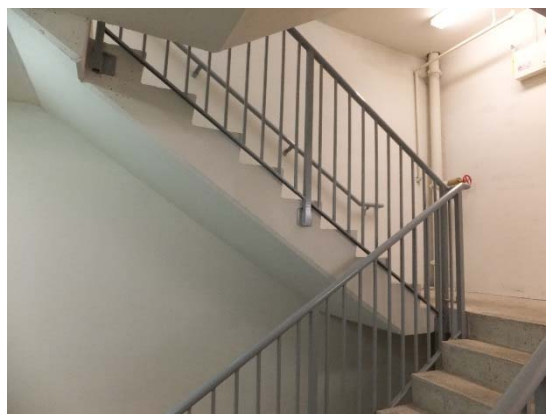
Year Installed	2005	Description: The corridors are finished with carpeted flooring and painted drywall for the walls and ceilings. Suite entrance and service closet doors are painted solid units in steel frames with standard locks and hardware. Lighting throughout the corridors is accomplished with a mixture of wall- and ceiling-mounted fixtures with standard bulbs. The stairwells consist of both painted and unpainted concrete walls, floors, and ceilings with metal handrails and fluorescent lights.
Expected Life Span	15-25	
Observed Condition	8	
Repair or Replace	4 & 13

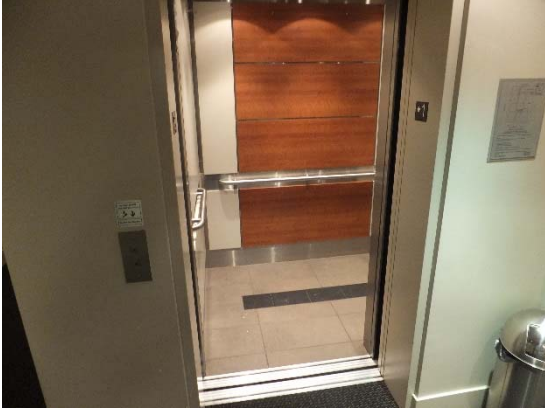
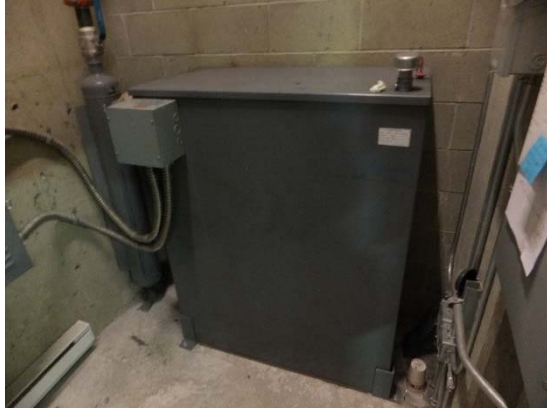
M 1 – Elevator		
Year Installed	2005	Description: The building has a single hydraulic cylinder elevator that services all levels. The elevator is manufactured by Richmond Elevator Maintenance Ltd. The elevator room is located in the parkade level of the building and it houses the hydraulic equipment and the safety switch. The elevator cab is finished with tile flooring, wall panels and fluorescent lighting.
Expected Life Span	25-30	
Observed Condition	8	
Repair or Replace	18	
<div style="display: flex; justify-content: space-around;">

</div>		
<p>Financial Review: We understand that the elevator is part of the original construction. We are not aware of any replacements or significant repairs to this component.</p>		
<p>Visual Review: The Strata has a full elevator maintenance agreement with Richmond Elevator Maintenance. This means that parts replacement for regular wear and tear is covered. The Contractor performs full maintenance and inspections on a monthly basis and the cost is the contract price at the building.</p> <p>According to the service contractor the elevators are operating well and are in operable condition.</p>

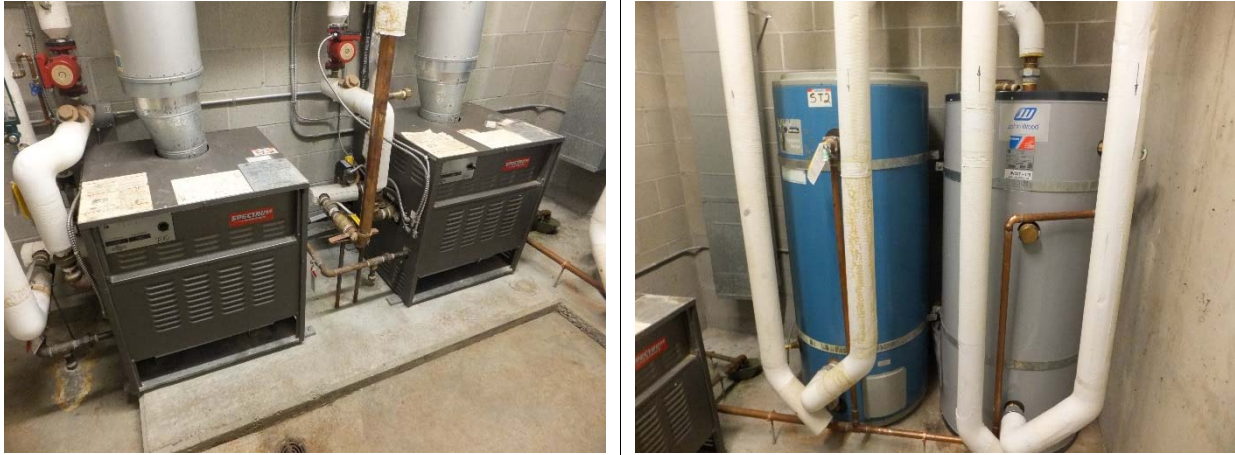
P 1 – Domestic Water System		
Year Installed	Various	Description: Domestic water enters the building via buried piping fed from the main municipal line connected to a combined incoming domestic water and suppression line supply line through the parkade wall. The domestic cold water then branches off into separate suppression and domestic water lines. The gas-fired heating boilers are manufactured by RBI Water Heaters and they each have an attached recirculation pump. Along with the boilers are two 119 US gallon storage tank manufactured by John Wood and an expansion tank.
Expected Life Span	Various	
Observed Condition	Various	
Repair or Replace	23 & 29

<p>Financial Review: We understand that the distribution piping is original to the property and has not received any major repairs. The boilers are also original to the building but one of the two hot water storage tanks was replaced in 2013 at a cost of approximately \$3,000, from the operating budget, and the second is scheduled to be replaced sometime in 2014, also from the operating budget.</p>

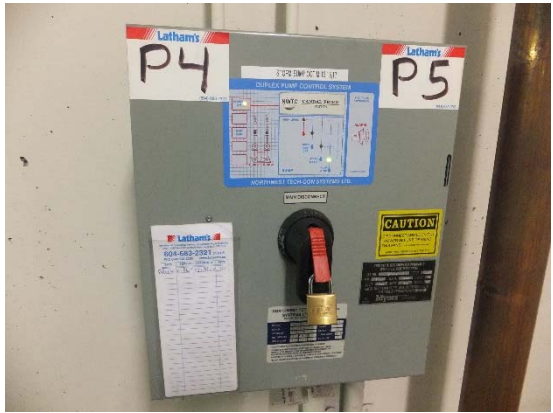
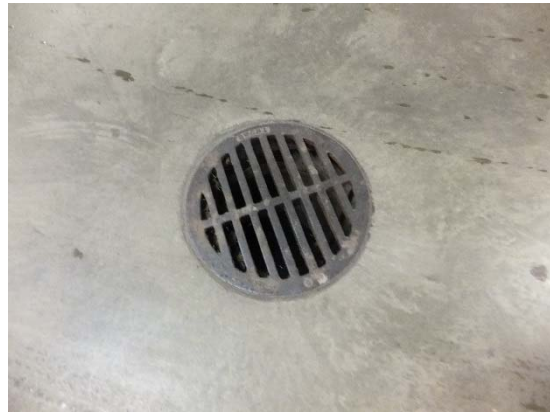
P 2 — Drainage, Sanitary & Storm Sewer, Sump Pumps		
Year Installed	2005	Description: According to the building plans, the parkade has one duplex 1 ½ hp sump pump (storm) and one simplex ½ hp pump (sanitary) with level alarm systems. The alarm controls are located within the parkade. The concrete slab-on-grade floor slab is sloped toward the catch basin and out of the parkade area. There is sanitary and storm drainage piping connected to the site service lines and the municipal sewage system.
Expected Life Span	15-25	
Observed Condition	8	
Repair or Replace	11

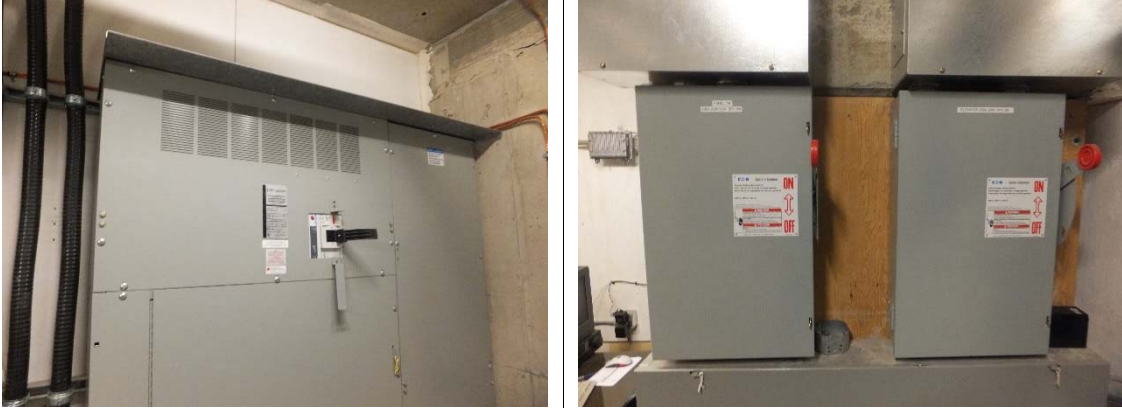
EL 1 – Electrical Systems		
Year Installed	2005	Description: Electrical service is supplied to the building from buried municipal service to the main electrical room at the parkade level. The room houses a 1200A switchgear unit and two 200A safety switches, a main distribution breaker and other related electrical system peripherals. The individual suite meters are located in separate electrical closets throughout the property.
Expected Life Span	50+	
Observed Condition	8	
Repair or Replace	14

<p>Financial Review: We understand that the electrical systems are part of the original construction. We are not aware of any replacements or significant repairs to this component.</p>		
<p>Visual Review: The level of interior finish, heating, and lighting is minimal and has not been considered. All meters and telecommunication components are assumed to be the responsibility of the service provider and have not been considered.</p> <p>The electrical room appeared to be clean and well organized. The areas reviewed showed no sign of damage to the switches, panels, or any other equipment.</p> <p>Generally, the electrical room appears to be in good condition consistent with its chronological age.</p>

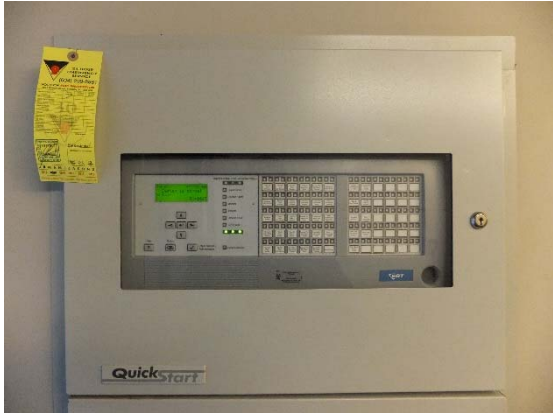
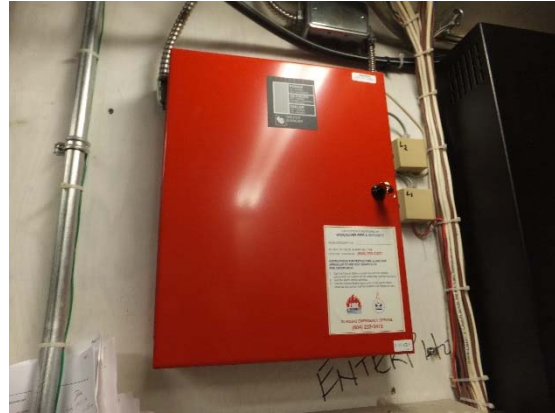
SS 1 – Fire Alarm System		
Year Installed	2005	Description: The property is equipped with an EST alarm system. There is an annunciator panel located in the common lobby area and other related items in the parkade-level mechanical room. There are pull stations, bells, heat and smoke detectors located throughout the building.
Expected Life Span	20-25	
Observed Condition	8	
Repair or Replace	13

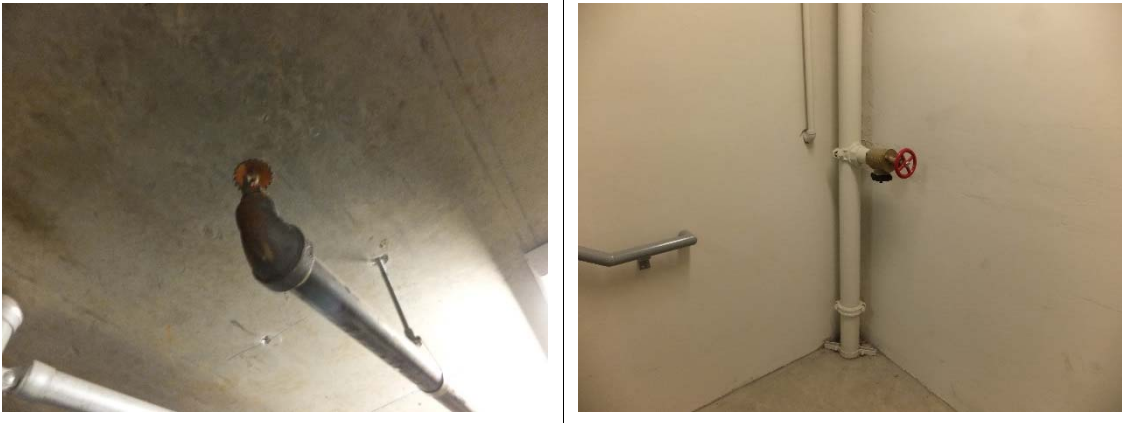
SS 2 – Suppression		
Year Installed	2005	Description: There is a combined incoming water line that enters the building and branches into a suppression line that is protected with a backflow prevention valve. The building is equipped with a wet suppression system that supplies the standpipe risers within the stairwells and the above ground sprinkler system. The parkade has a dry suppression valve servicing a dry sprinkler system. There are also wall mounted fire extinguishers supplied throughout the building. There is a Siamese connection (fire department hose hookups) located at the exterior of the property.
Expected Life Span	60+	
Observed Condition	8	
Repair or Replace	11

Financial Review: We understand that the fire suppression and service lines are part of the original construction. We are not aware of any replacements or significant repairs to this component.		
Visual Review: We were unable to determine the condition of the buried and concealed piping, but there was no visual damage to visible piping, sprinkler heads, standpipes or extinguishers at the time of our visit.

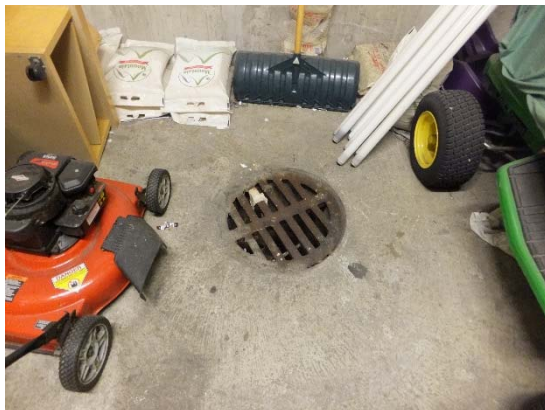
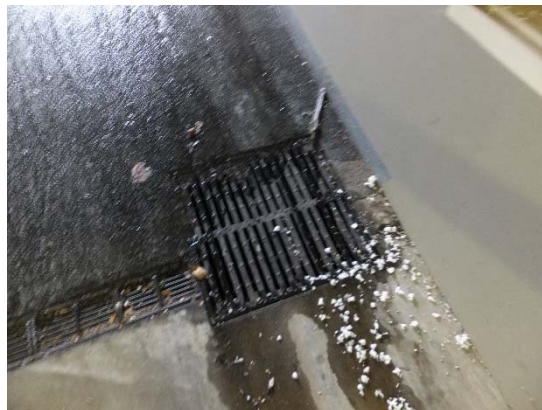
SRV 1 – Buried Site Services		
Year Installed	2005	Description: Site services include sanitary and storm piping, gas piping, and electrical wiring. They are supplied to the building via buried conduits and piping fed from main municipal lines below the adjacent roads.
Expected Life Span	60+	
Observed Condition	8	
Repair or Replace	n/a

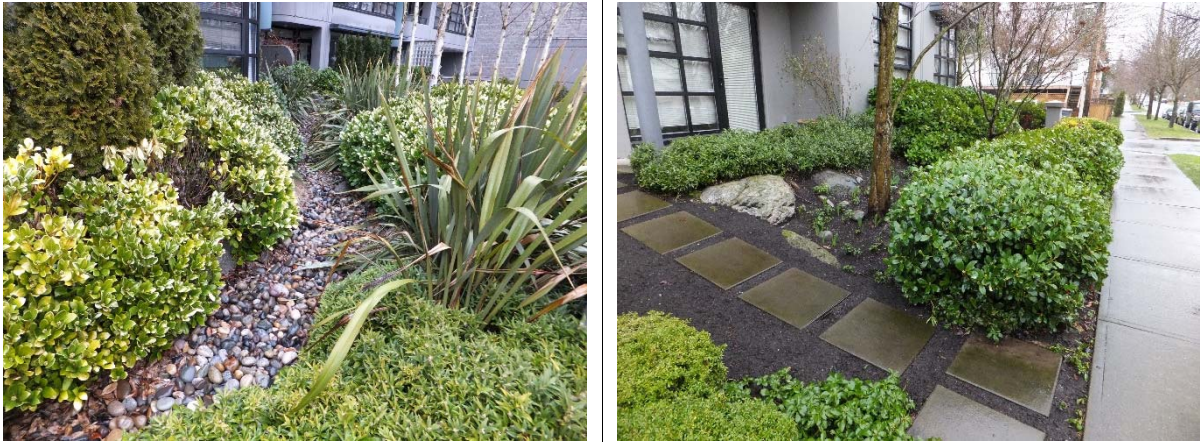
Site 2 – Landscaping (Hard & Soft)		
Year Installed	2005	Description: Site landscaping consists of various hard and soft landscaping components. Trees, shrubbery, flowerbeds and sodded areas are incorporated throughout the site with some areas being held up with the aide of relatively low concrete retaining walls. Hard landscaping surfaces including the concrete parkade entrance and walkways are discussed in foundation and parkade roof deck sections of this report and therefore excluded from this component. All landscaped areas above the parkade roof deck have been included in component S2 and therefore excluded from this component.
Expected Life Span	25+	
Observed Condition	8	
Repair or Replace	n/a
