2-Year Warranty Review Report - DRAFT

District Crossing, 1673, 1677 and 1679 Lloyd Avenue, North Vancouver, BC

PROJECT # 6064.10

DATE July 10, 2013

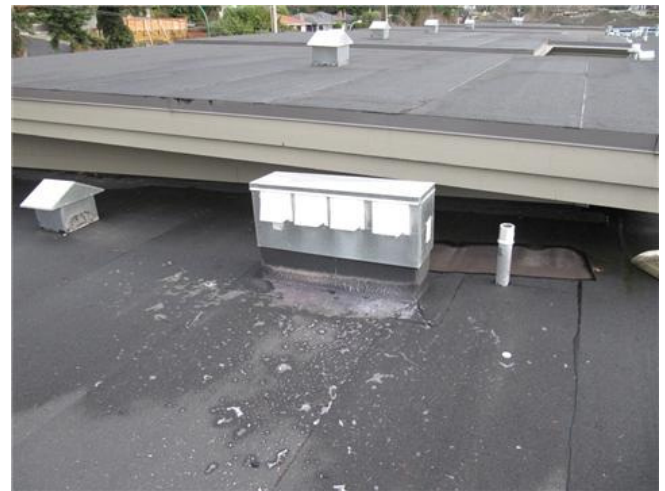
We observed some accumulation of lint at the roof below dryer exhaust vents. Exhaust vents should be cleaned as part of a regular maintenance program; as well residents should be encouraged to clean lint traps within dryers regularly (Fig. 4.3.1).

Fig. 4.3.1 Lint accumulation below dryer vents at roof level.

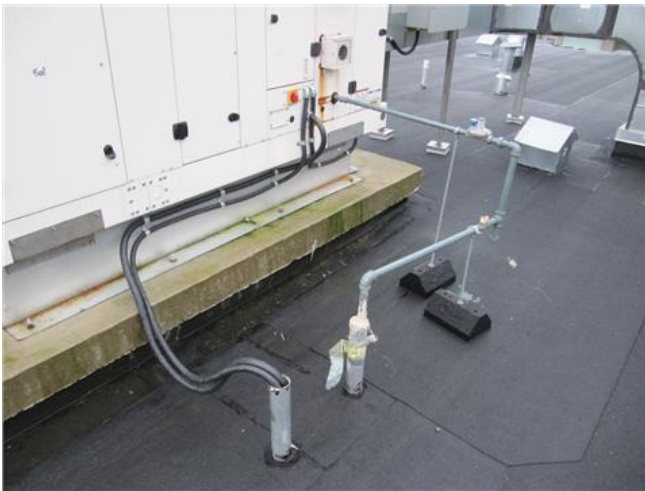
We noted that gooseneck flashings were not installed at electrical penetrations through the roof, as indicated in the architectural drawings and instead penetrations were either left exposed or sealed with sealant (Fig. 4.3.2).

Fig. 4.3.2 Improperly sealed electrical penetrations at roof level.

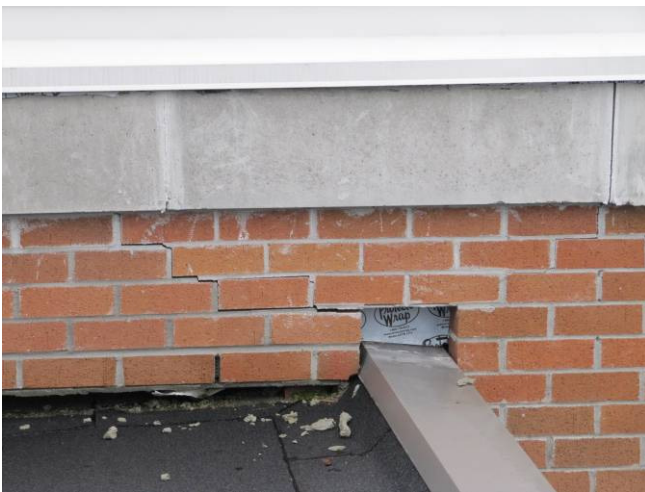
At several areas on the roof level of the buildings we observed loose bricks and cracks within the mortar joints at the masonry clad parapet walls. Cracking is likely due to differential settling or shrinkage within the framing members. Additionally, we observed sections of self-adhesive membrane which was left exposed (Fig. 4.3.3).

Fig. 4.3.3 Loose bricks and cracked mortar joints at roof level.

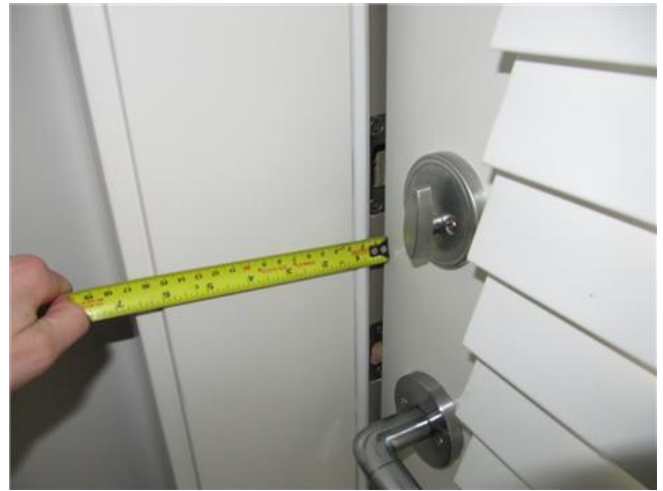
At suite 301, in 1677 Lloyd, the balcony swing door is out of alignment and is not closing properly. The door should be adjusted to ensure it may be properly closed and locked (Fig. 4.3.4).

Fig. 4.3.4 Exterior balcony door at suite 301, 1677 Lloyd.

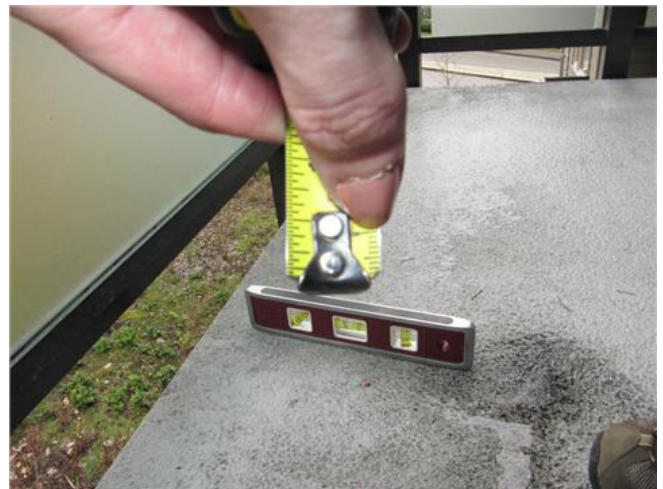
The balcony surface at suite 506, 1679 Lloyd, was not adequately sloped to the exterior and had a back slope of up to 1/2", resulting in minor ponding near the balcony edge (Fig. 4.3.5).

Fig. 4.3.5 Backslope of balcony surface at suite 506, 1679 Lloyd.

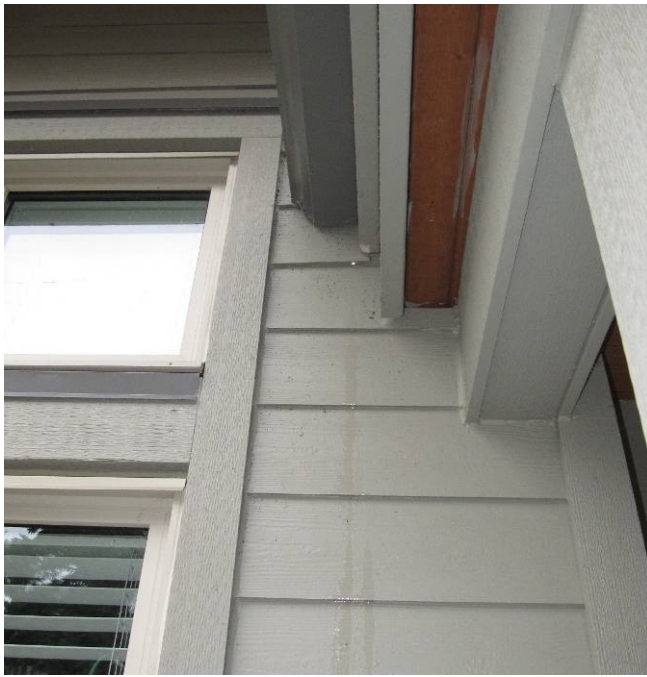
Also at unit 506, we observed water draining onto the wall assembly from the gutter for the balcony above. It appears that the gutter is sloped towards the wall and is not well sealed (Fig. 4.3.6).

Fig. 4.3.6 Water draining onto wall assembly from balcony gutter above.

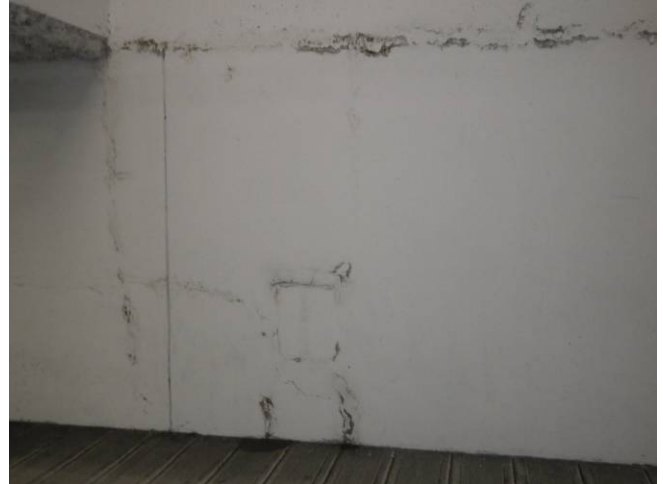
time; however these areas should be monitored.

Fig. 4.3.7 Water ingress along entry ramp exterior wall.

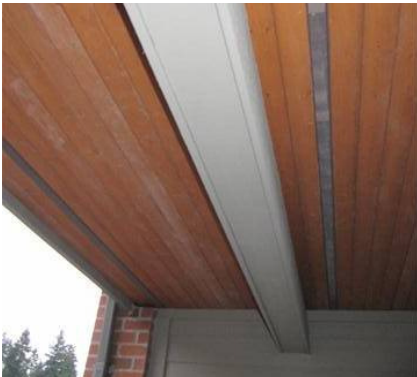
WR 002

Staining observed on wood soffit.

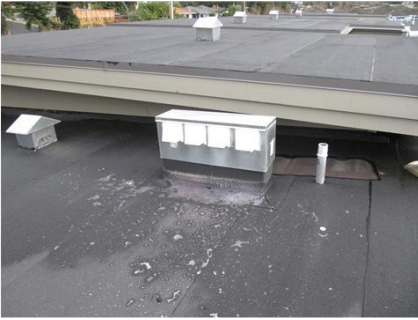
WR 003

Dryer lint accumulation on lower roof level under vent hoods.

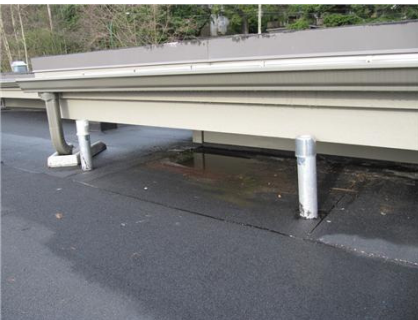
WR 004

Minor ponding observed below raised roof section.

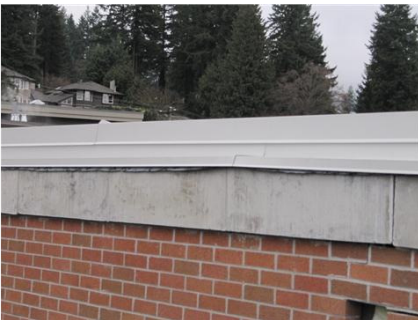
WR 005

Exposed membrane under flashing at roof. Membrane is not well adhered in some locations.

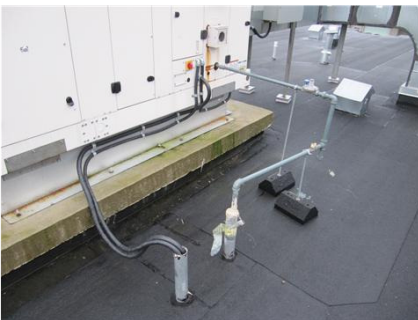
WR 006

Unsealed roof penetrations at mechanical unit.

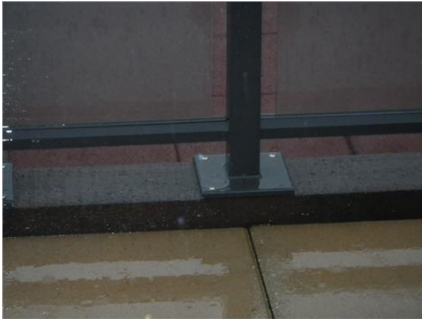
WR 007

Missing screw in top-mounted guardrails on deck at roof level.

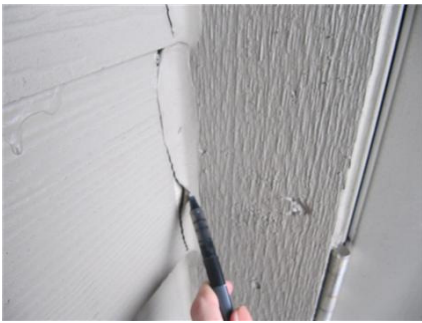
WR 008

Peeling sealant at exterior wall interface between fibre cement board siding and wood trim.

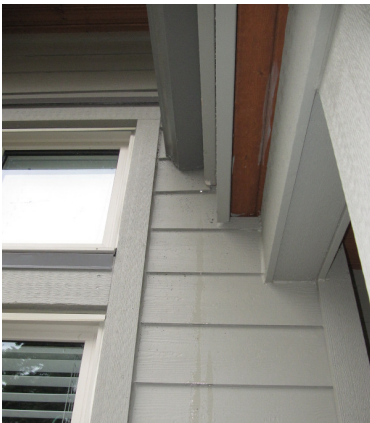
WR 009

Water leaking from gutter onto exterior wall.

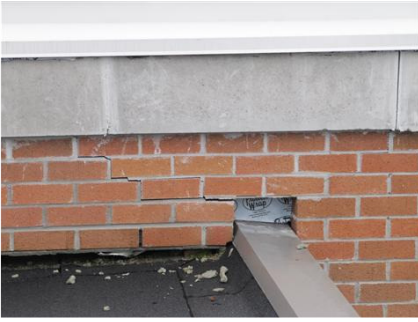
WR 010

Exposed self adhesive membrane at roof parapet.

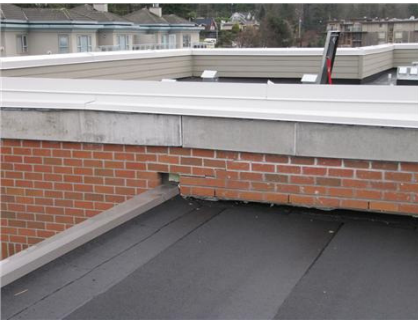
WR 011

Cracks in brick mortar, loose and missing bricks at roof level.

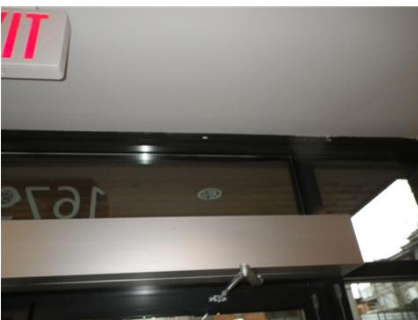
WR 012

Loose gasket at lobby window assembly.

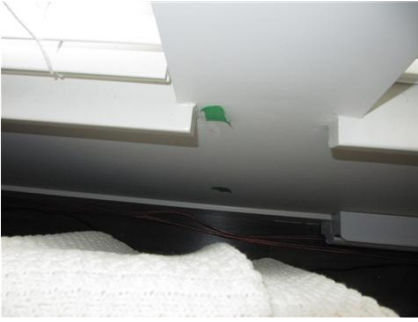
WR 013

Various cracks were observed at the interior drywall finish.

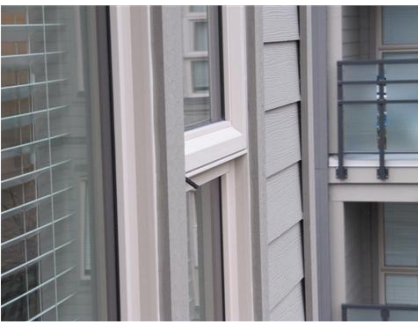
WR 014

Weatherstripping loose at operable windows.

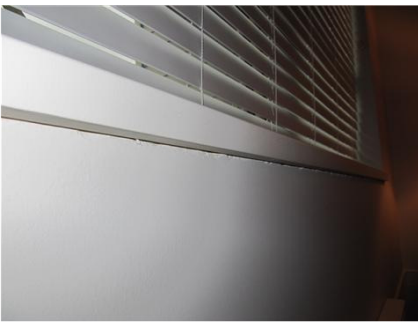
WR 015

Poorly finished drywall below interior window sill.

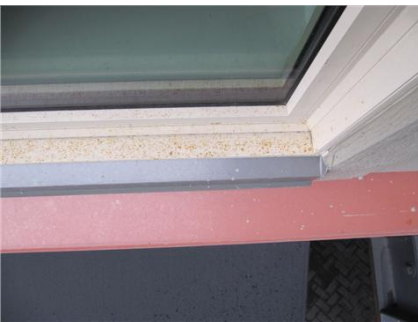
WR 016

Rust staining at window frame exterior.

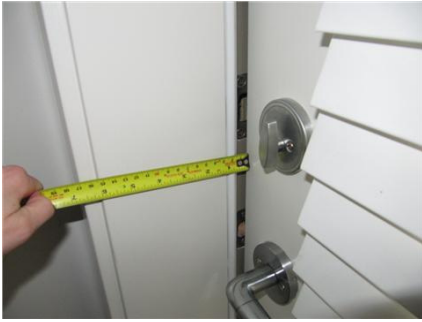
WR 017

Exterior door difficult to close.

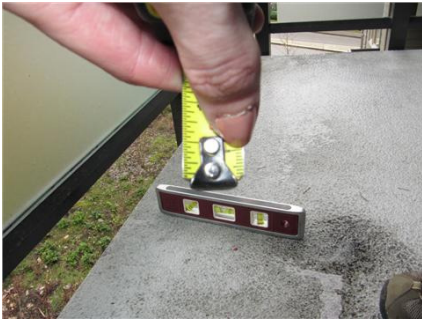
WR 018

Water staining on balcony surface.

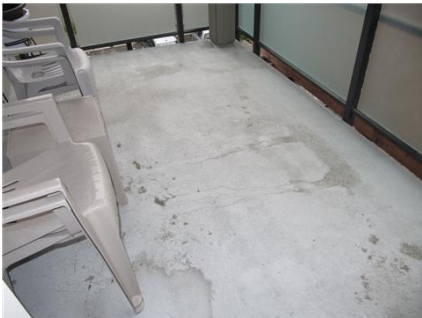
WR 019

Water staining on balcony surface.

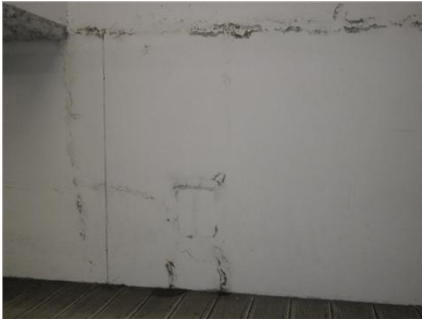
WR 020

Cracks and dark stains on wall by parkade ramp

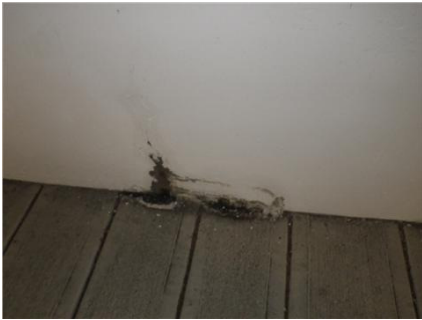
WR 021

Cracks and staining at interface of ramp and wall.

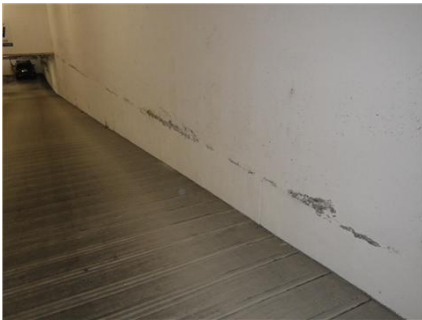
WR 022

Evidence of moisture ingress along cold joint in exterior parkade wall by ramp.

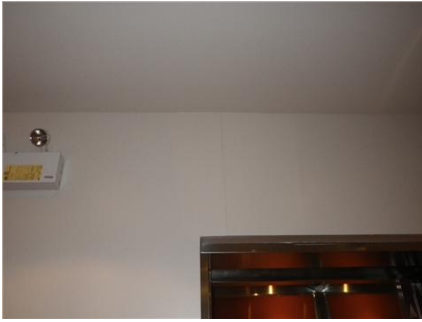
WR 023

Crack in wall above elevator shaft.

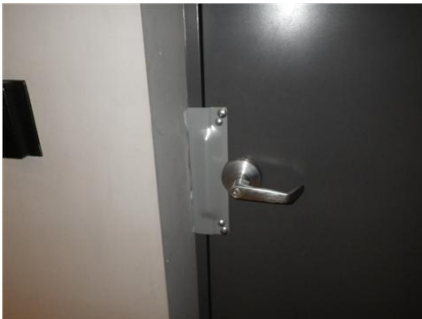
WR 024

Steel exit door not closing properly, damaging adjacent wall finish.

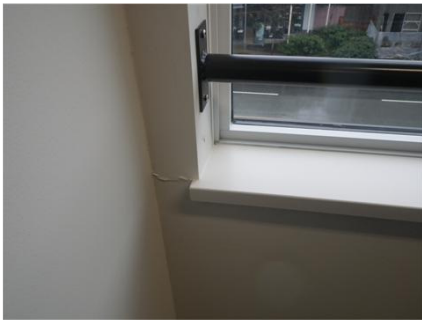
WR 025

Crack in interior wall near window.

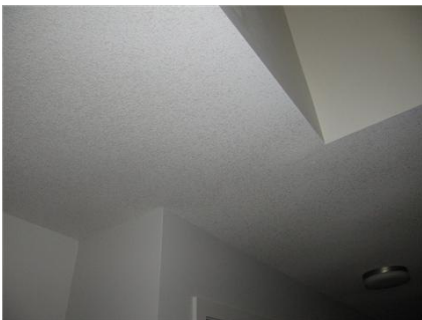
WR 026

Cracks at interior ceiling finish.

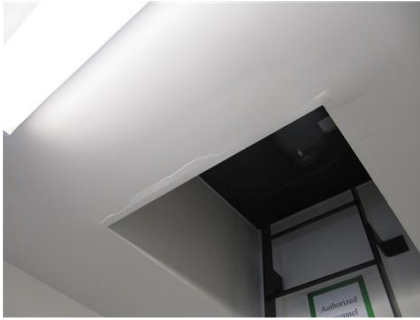
WR 027

Crack in ceiling finish at roof hatch.

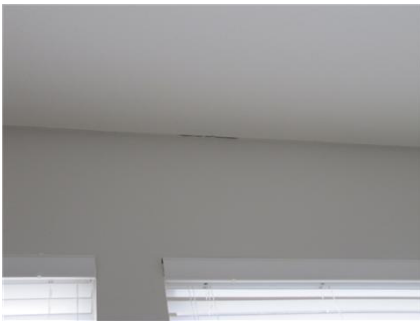
WR 028

Crack at interface of ceiling and wall.
