# District Crossing Mechanical and Electrical Warranty Review

Prepared for: RDH Building Engineering Ltd  
[www.rdhbe.com](http://www.rdhbe.com)  
Vancouver, BC

Prepared by: Besant and Associates Engineers Ltd  
[besanteng.ca](http://besanteng.ca)  
tel: 604 990-1751 & fax: 604 689-4690

Date: 12 July 2013 (draft)

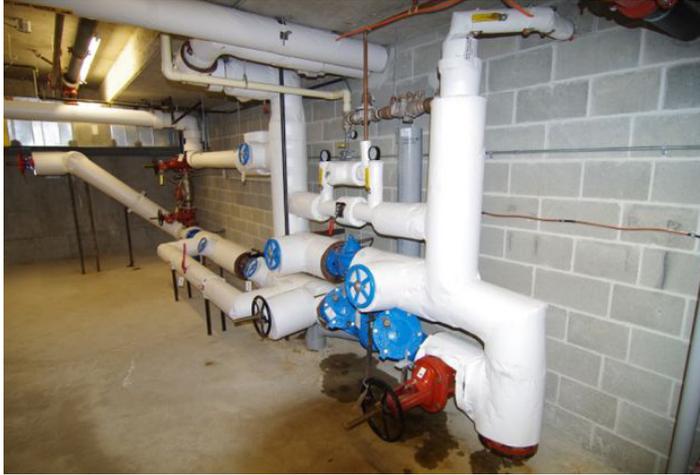
*Photo 5.1 — Main domestic water line showing the pressure reducing valves on water supply and the backflow preventers. The incoming pressure is 110 psi and the supply pressure to building is 50 psi.*

As a cautionary note, we should state that domestic water piping is susceptible to failure in BC because the water in the lower mainland is considered to be aggressive. This is the result of low pH and the softness of our water. This was identified as problem in the early 90s by the Association of Professional Engineers of BC (APEGBC). At that time, recommended addressing the problem with “aggressive” water by ensuring water velocities are maintained below certain thresholds.

We typically find that the piping lasts about 20 years before problems develop. Even plastic piping systems may be affected by water chemistry. There is evidence to suggest that our water conditions will lead to embrittlement of the plastic pipe. That said, we are relying upon our own experience with this problem and not comprehensive statistical data. Also, there are many factors that affect the operating life of domestic water piping including water velocity.

There are a number of options for addressing problems with domestic water piping. One method is to add minerals to the water to mitigate the damage caused by the low pH and softness (Hytec Water Management Ltd, richard@hytecwater.com .ca and 604-628-2421 (office) has this kind of system).

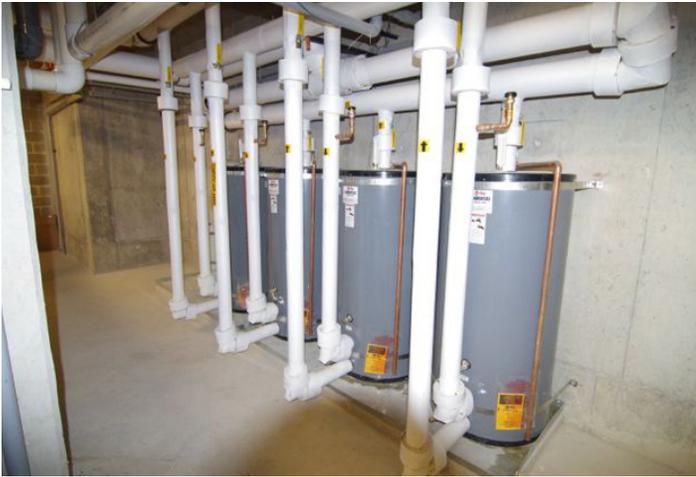
storage tanks (Photo 5.2) each have a storage capacity of 115 US Gallons. The thermometers on each tank show the storage temperature to be approximately 135°F. There is an expansion tank on the hot water system and fractional horsepower re-circulation pumps controlled by aquastats.

*Photo 5.3 — Main domestic hot water storage tanks and expansion tank. Temperature noted to be 135°F.*

The domestic hot water storage tanks will also remain in service for much longer with a water treatment system employed for this building.

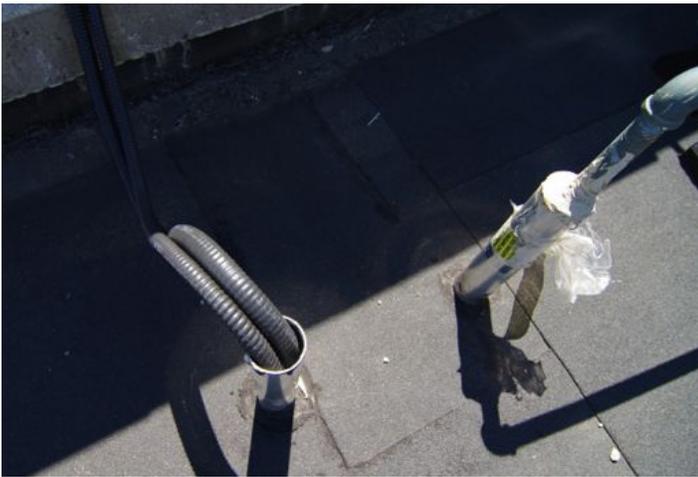
Item #	Title	Discussion	Location	Photo Ref #
M.1	No balancing report available for our review.	A balancing report should be available on site to determine how much outside air is being delivered to the corridors.		
M.2	Water-proofing missing on cable penetration on make-up air unit	The cable penetration through the roof is not adequately water-proofed. Ideally, this penetration should be caulked and have a neoprene boot connected to the conduit.	Roof Level 1673 Lloyd Ave	<b>A</b>

*Photo A -- Make-up Air Unit mounted on roof. Note the lack of caulking at roof penetration for electrical wiring.*

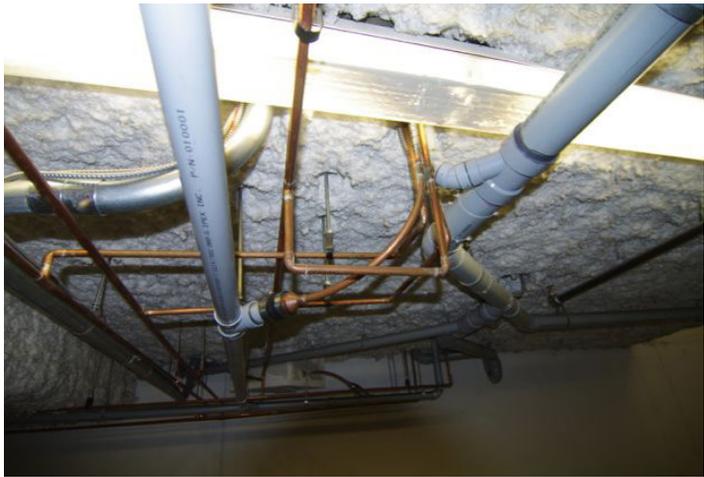
Item #	Title	Discussion	Location	Photo Ref #
P.1	No commissioning report available for our review.	We were not able to determine if all of the alarms were functional. For example, we don't know if the sump pump audible alarm has been tested.		
P.2	It appears that there is insulation missing from the trap primer piping in the parking garage.	It is good practice to insulate all fittings where there is a risk of freezing.	Parking garage	<b>B</b>
P.3	There is soil erosion around a storm drain common area patio.	Soil erosion evident on around amenity area patio	2nd floor amenity area	<b>C</b>

*Photo B -- What appears to be un-insulated copper piping for trap primers at the entrance to the parking garage..*

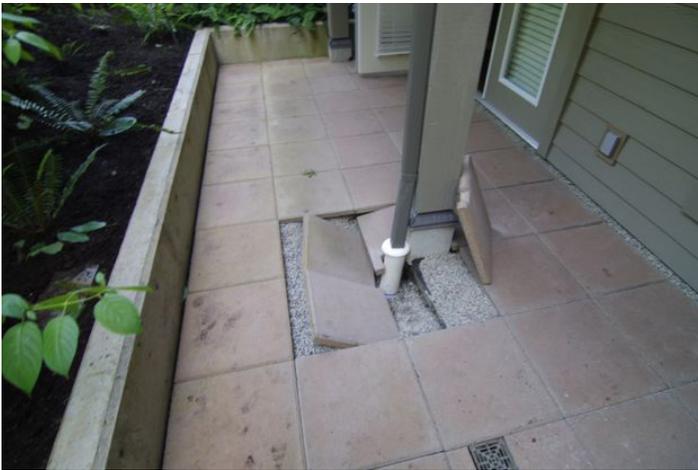
*Photo C -- Soil erosion around storm drain on amenity patio area.*

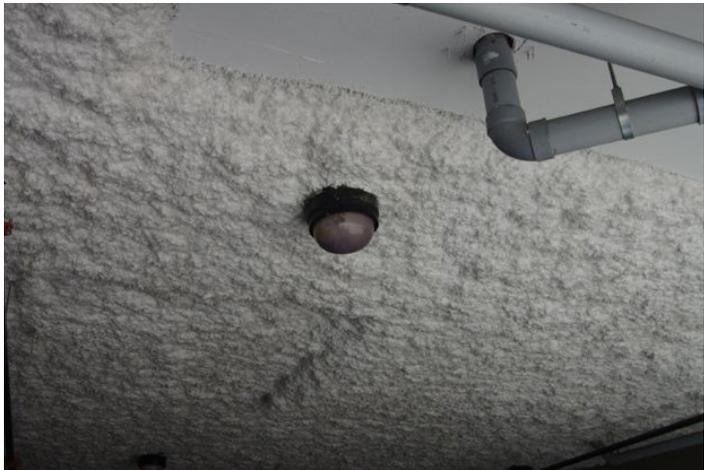
Item #	Title	Discussion	Location	Photo Ref #
E.1	Evidence of electrical problems in 1679 Lloyd	Building manager and electrician report problems with lighting. Fixtures require constant attention because lamps fail regularly.	Throughout 1679 including parking garage and occupied areas.	<b>D</b>

*Photo D -- Problems with light fixtures throughout building. Lamps are failing far too frequently.*
