Strata BCS 1265 Bel Air Depreciation Report

The Owners, Strata BCS 1265
Bel Air
2828 Yew Street
Vancouver, BC, V6K 4W5

March 25, 2014

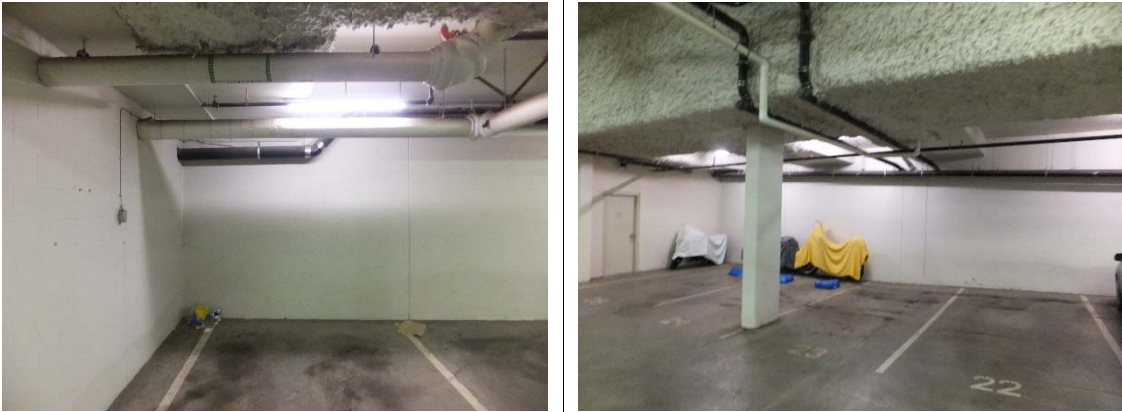
S 1 – Foundation & Structure		
Year Installed	2005	Description: The main structure of the building consists of cast-in-place concrete framing including columns, beams and suspended floor slabs. The interior walls have steel studs. The structure is supported on a reinforced cast-in-place concrete foundation. The parkade is primarily located below the footprint of the building. The perimeter foundation walls are likely protected with a damp-proofing or waterproofing membrane to mitigate water ingress. The footings are likely cast-in-place strip footings at foundation walls and concrete pad footings at columns. The flooring at the lowest level of the parkade consists of a reinforced concrete slab on grade with catch basins for drainage.
Expected Life Span	80+	
Observed Condition	8	
Repair or Replace	10

<p>Visual Review: The concrete-framed structure of the building is typically concealed by exterior coatings and interior finishes. Portions of the foundation walls that extended above grade appeared to be protected with a damp-proofing or waterproofing membrane. The interior side of the foundation walls, viewed from within the parkade, are painted white and parking space numbers and lines are painted on the surface of the slab-on-grade. From the interior of the parkade, where checked, we did not note any serious cracking or other areas of concern beyond typical settling and one small isolated section in a stairwell that was pointed out to us by a Strata council member which will likely be addressed under general building maintenance.</p>		
<p>Recommendations: The foundation and structure can deteriorate due to several factors such as hydrostatic pressure, seismic activity, or water infiltration through the cracks in foundation walls and exterior wall cladding, as well as typical building settlement. Foundation walls located below grade are susceptible to leaks if cracks form along the walls allowing moisture to penetrate into the parkade area. Structural components typically last the life of the building, so full replacements have not been considered in this Report. However, there is potential for failure of some of the waterproofing.</p> <p>To mitigate water penetration, in the plan we have included an allowance for isolated concrete repairs to perimeter foundation walls below grade, starting in the year 2023 and every 20 years thereafter. Typically these repairs include the injection of waterproofing materials into cracks along the concrete foundation walls as well as concrete repairs.</p>

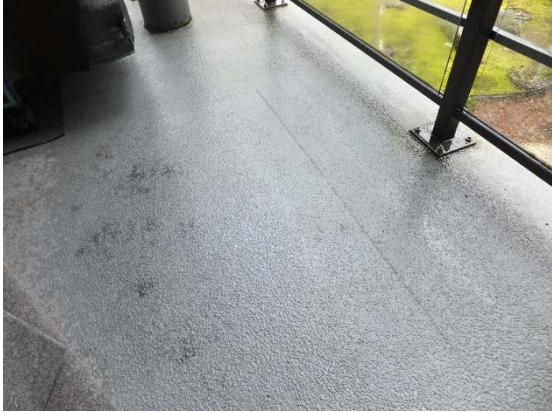
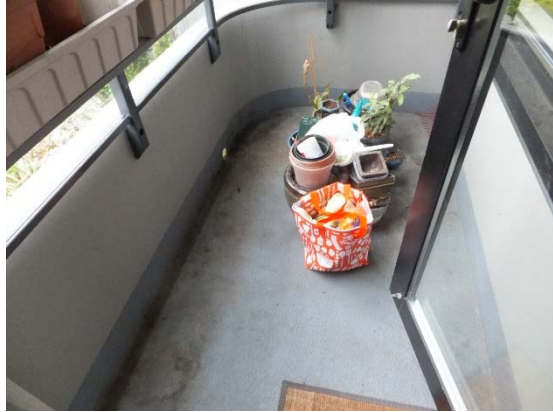
S 3 — Balconies		
Year Installed	2005	Description: Balcony assemblies consist of cantilevered extensions of the reinforced concrete floor slab that extend past the exterior walls. The top surfaces of the slabs are finished with an elastomeric membrane with a granular embedded top coat. The balcony slabs are sloped to the outer edges for drainage. The soffits and slab edges of the balconies are painted with an elastomeric paint finish.
Expected Life Span	20	
Observed Condition	8	
Repair or Replace	12	
<div style="display: flex; justify-content: space-around;">

</div>		
<p>Financial Review: We understand that the balconies are part of the original construction. We are not aware of any replacements or significant repairs to this component.</p>		
<p>Visual Review: We reviewed the balconies from grade, the roof level and the accessed suites and have assumed that all sections throughout the building are similar to the ones observed. We noted no significant cracking or deterioration of the membrane on the surface of the reviewed balconies, where checked.</p>

<p>Recommendations: Over time and with exposure to weather and Ultra-violet (UV) rays the elastomeric membrane coating the surface of the balcony floors will start to deteriorate and fail. Cracks may also form along the concrete allowing for moisture ingress resulting in deterioration of the concrete similar to that described in the sections S1 and S2 of this report.</p> <p>The plan allows reapplication of the balcony surface coat plus allowances for localized repair to the concrete balcony slabs to occur every 20 years with the first occurrence starting in the year 2025. The repair costs also include allowances for concrete repairs, routing and sealing of cracks and installation of a new elastomeric waterproofing membrane.</p> <p>We recommend that the Strata perform annual inspections of the balconies to monitor their condition and ensure that there are no safety concerns.</p>

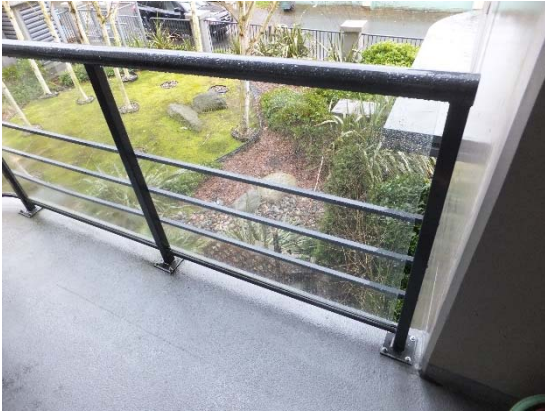
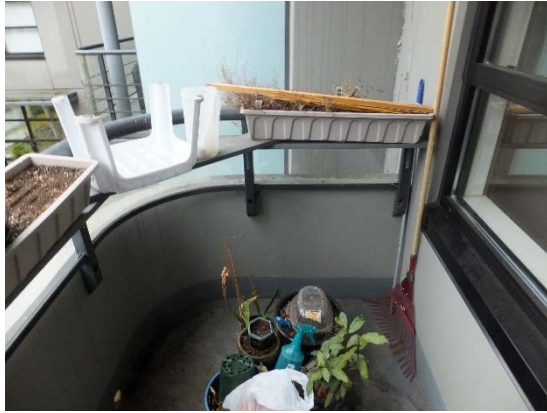
S 4 – Balcony Guards		
Year Installed	2005	Description: The balconies have two different guard styles. One type is a full height, surface-mounted metal post and handrail assembly with safety glass inserts and the other type consists of shorter, side-mounted metal assemblies attached to concrete pony walls.
Expected Life Span	20-30	
Observed Condition	8	
Repair or Replace	12	
<div style="display: flex; justify-content: space-around;">

</div>		
<p>Financial Review: We understand that the balcony guards are part of the original construction. We are not aware of any replacements or significant repairs to this component.</p>		
<p>Visual Review: We reviewed the balconies from grade, the roof level and the accessed suites and have assumed that all sections throughout the building are similar to the ones observed.</p> <p>We only performed a visual review of the assemblies and did not perform any physical testing as it was not in our scope. Where checked, guards appeared to be intact and secured.</p>

<p>Recommendations: Aluminum guard assemblies have a typical life expectancy of 20-30 years. Some guards wear quicker than others due to a number of potential factors such as different exposures to external elements and fluctuating wear-and-tear based on different uses.</p> <p>The plan allows for removal and replacement of approximately 50% of the aluminum guards to occur in correspondence with every balcony repair project. The first instance of the guard replacement is planned to commence in the year 2025 and then every 20 years thereafter.</p> <p>We recommend that along with the annual inspection of the balcony assemblies the Strata take note and monitor the condition of the guards as well.</p>

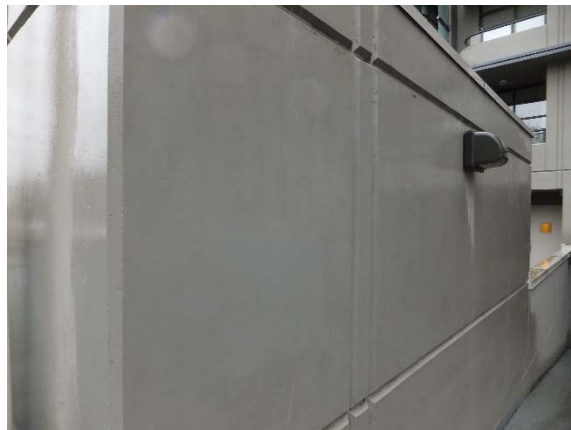
Year Installed	2005	Description: According to the building plans provided, exterior walls consist of cast-in-place concrete walls with paint applied throughout with sealants adhered around doors and windows and at transitional joints.
Expected Life Span	10-12	
Observed Condition	8	
Repair or Replace	4

Visual Review: From our visual review, from grade and the accessed balconies, there did not appear to be any obvious signs of deterioration or delamination of the concrete along the exterior surface of the walls, where checked.

Recommendations: Regular wall maintenance including cleaning and sealing will generally assist in mitigating premature deterioration and failure of the exterior cladding concrete walls. The coating will assist in mitigating water penetration at the exterior walls. Over time with weathering and aging the coating and sealants will begin to crack and break down requiring eventual replacement.

The plan allows for recoating the walls and replacement of the sealants to occur in 4 years and then every 12 years thereafter.

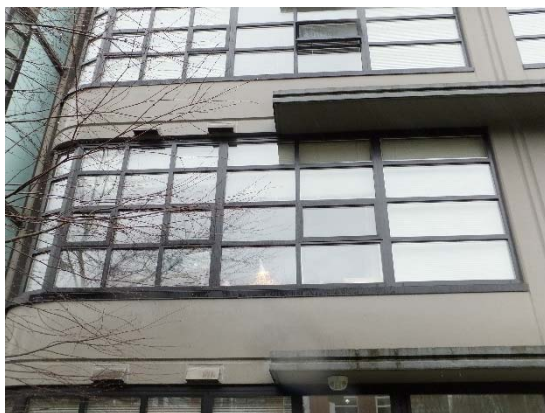
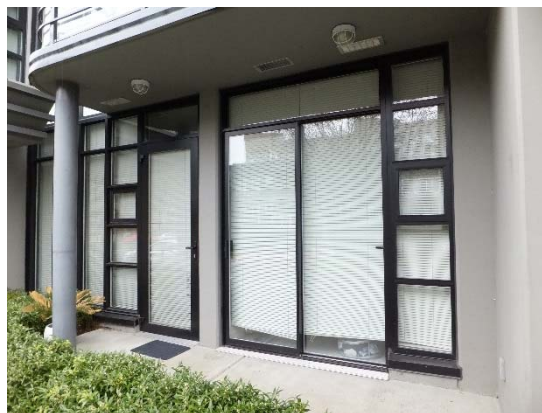
Year Installed	2005	Description: The windows and balcony entry doors both consist of double-glazed aluminum-framed units. There are an assortment of fixed and operable style window assemblies along with sliding and pivoting door assemblies. Window units are typically inset within the concrete walls with metal flashing at the head and foot of each window unit. Weep holes are provided at the base of the windows to allow for drainage. Window and door assemblies at the main entrances are discussed in the Exterior Doors section of this Report.
Expected Life Span	30-40	
Observed Condition	8	
Repair or Replace	27

Visual Review: From our visual review from grade and the accessed common areas we did not observe any major defects such as fogging or condensation between the glazing units. We did not conduct any performance tests on the operable window or door units but we have assumed that they are generally in good working condition based on the age of the building and the absence of any issues or complaints relayed to us.

Recommendations: Aluminum window frame assemblies typically have a life expectancy of 30-40 years. As the systems age and with exposure to the wet BC climate, seals may fail causing condensation and fogging between the glazing panes. Operable windows are susceptible to premature frame twisting as well as damaged or broken hardware and hinges. Over time the weather-stripping can become brittle and start to deteriorate.

We assume that periodic replacement of some windows will occur prior to full replacement of the window assemblies but they are assumed to be addressed on an as needed basis out of the operating budget. At the end of their expected life, the plan includes a replacement of the framed windows assemblies in 27 years and then every 35 years thereafter.

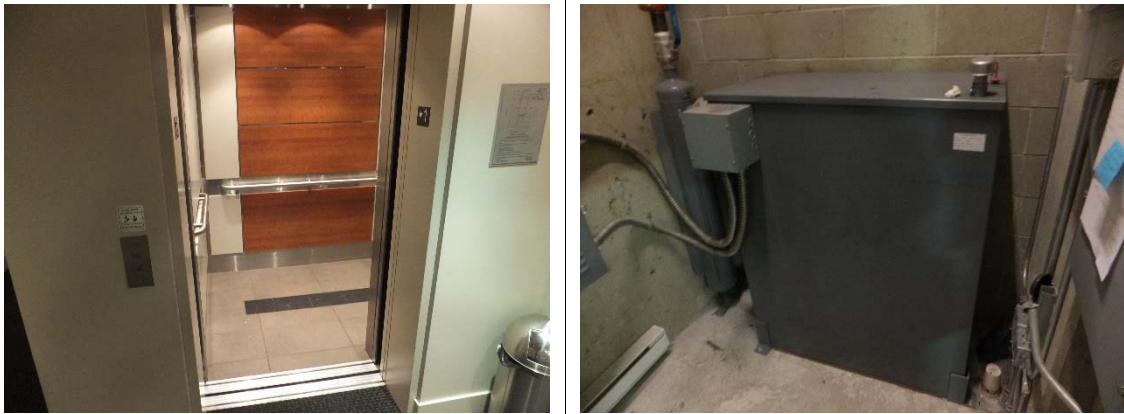
M 1 – Elevator		
Year Installed	2005	Description: The building has a single hydraulic cylinder elevator that services all levels. The elevator is manufactured by Richmond Elevator Maintenance Ltd. The elevator room is located in the parkade level of the building and it houses the hydraulic equipment and the safety switch. The elevator cab is finished with tile flooring, wall panels and fluorescent lighting.
Expected Life Span	25-30	
Observed Condition	8	
Repair or Replace	18

<p>Financial Review: We understand that the elevator is part of the original construction. We are not aware of any replacements or significant repairs to this component.</p>		
<p>Visual Review: The Strata has a full elevator maintenance agreement with Richmond Elevator Maintenance. This means that parts replacement for regular wear and tear is covered. The Contractor performs full maintenance and inspections on a monthly basis and the cost is the contract price at the building.</p> <p>According to the service contractor the elevators are operating well and are in operable condition.</p>

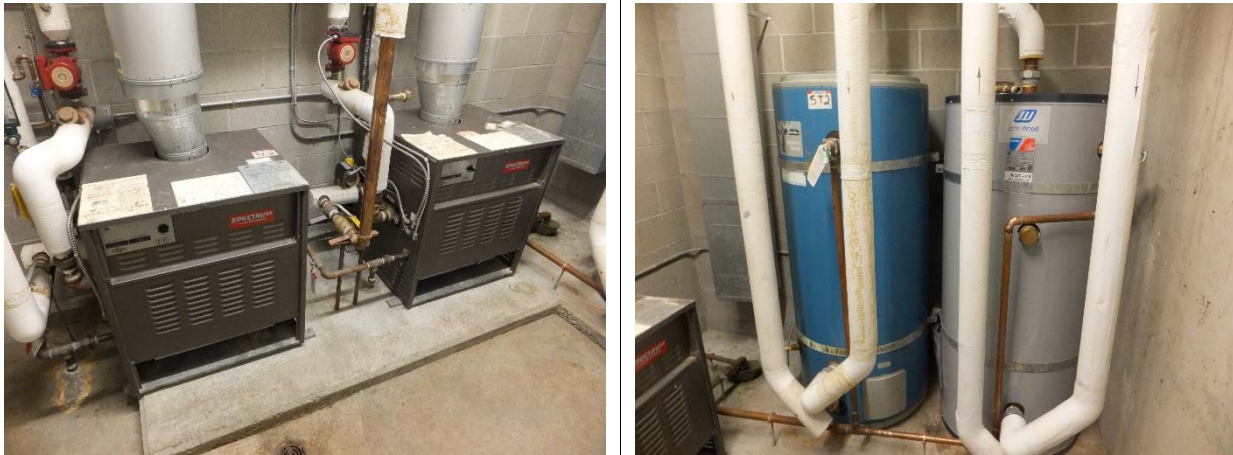
P 1 – Domestic Water System		
Year Installed	Various	Description: Domestic water enters the building via buried piping fed from the main municipal line connected to a combined incoming domestic water and suppression line supply line through the parkade wall. The domestic cold water then branches off into separate suppression and domestic water lines. The gas-fired heating boilers are manufactured by RBI Water Heaters and they each have an attached recirculation pump. Along with the boilers are two 119 US gallon storage tank manufactured by John Wood and an expansion tank.
Expected Life Span	Various	
Observed Condition	Various	
Repair or Replace	23 & 29

<p>Financial Review: We understand that the distribution piping is original to the property and has not received any major repairs. The boilers are also original to the building but one of the two hot water storage tanks was replaced in 2013 at a cost of approximately \$3,000, from the operating budget, and the second is scheduled to be replaced sometime in 2014, also from the operating budget.</p>

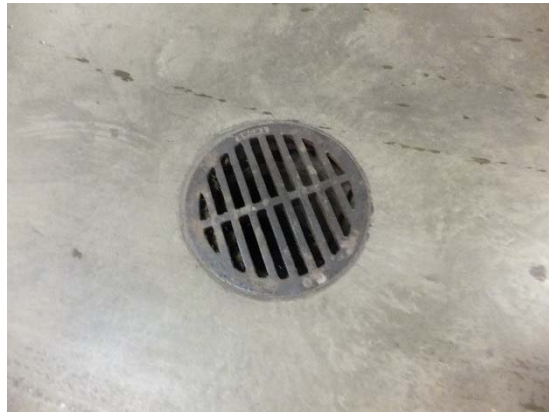
P 2 — Drainage, Sanitary & Storm Sewer, Sump Pumps		
Year Installed	2005	Description: According to the building plans, the parkade has one duplex 1 ½ hp sump pump (storm) and one simplex ½ hp pump (sanitary) with level alarm systems. The alarm controls are located within the parkade. The concrete slab-on-grade floor slab is sloped toward the catch basin and out of the parkade area. There is sanitary and storm drainage piping connected to the site service lines and the municipal sewage system.
Expected Life Span	15-25	
Observed Condition	8	
Repair or Replace	11

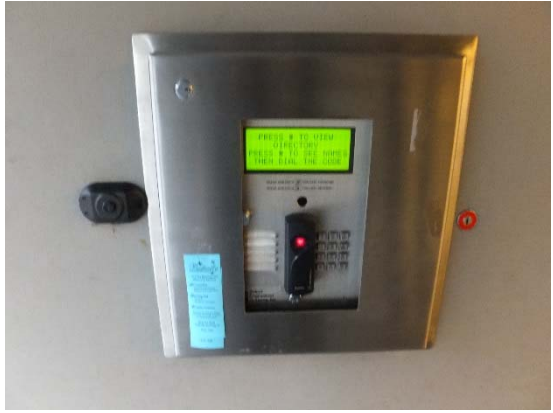
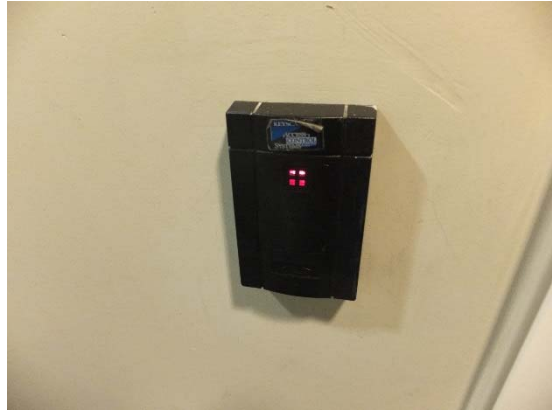
Year Installed	2005	Description: The building is equipped with an Enterphone 2000 access control system with an access panel located at the main lobby entrance. Access to common areas is granted to residents with a Keyscan access control fob system. Additional equipment for both systems is located in the parkade electrical room. The building has a security system with a camera that is monitored on site. The digital recording and monitoring equipment is also located at the electrical room.
Expected Life Span	15-25	
Observed Condition	8	
Repair or Replace	10

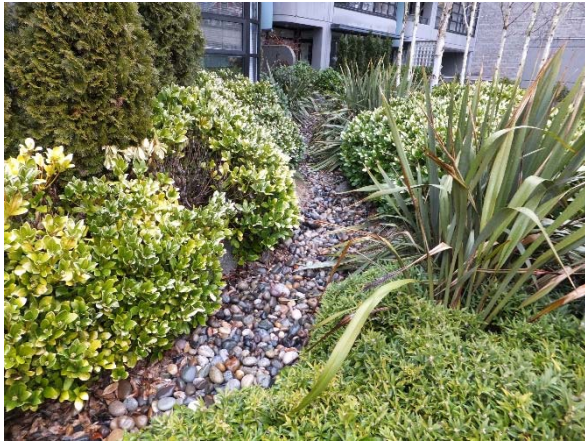
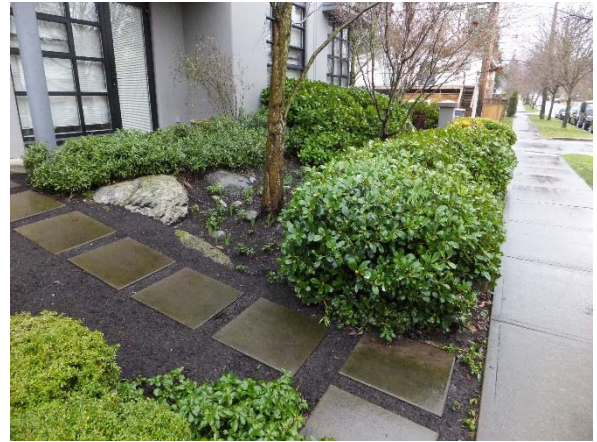
Site 2 – Landscaping (Hard & Soft)		
Year Installed	2005	<p>Description: Site landscaping consists of various hard and soft landscaping components. Trees, shrubbery, flowerbeds and sodded areas are incorporated throughout the site with some areas being held up with the aide of relatively low concrete retaining walls.</p> <p>Hard landscaping surfaces including the concrete parkade entrance and walkways are discussed in foundation and parkade roof deck sections of this report and therefore excluded from this component.</p> <p>All landscaped areas above the parkade roof deck have been included in component S2 and therefore excluded from this component.</p>
Expected Life Span	25+	
Observed Condition	8	
Repair or Replace	n/a
