Strata Property Act
SECTION 59 (Form B) INFORMATION CERTIFICATE

Strata BCS 1265 Bel Air Depreciation Report

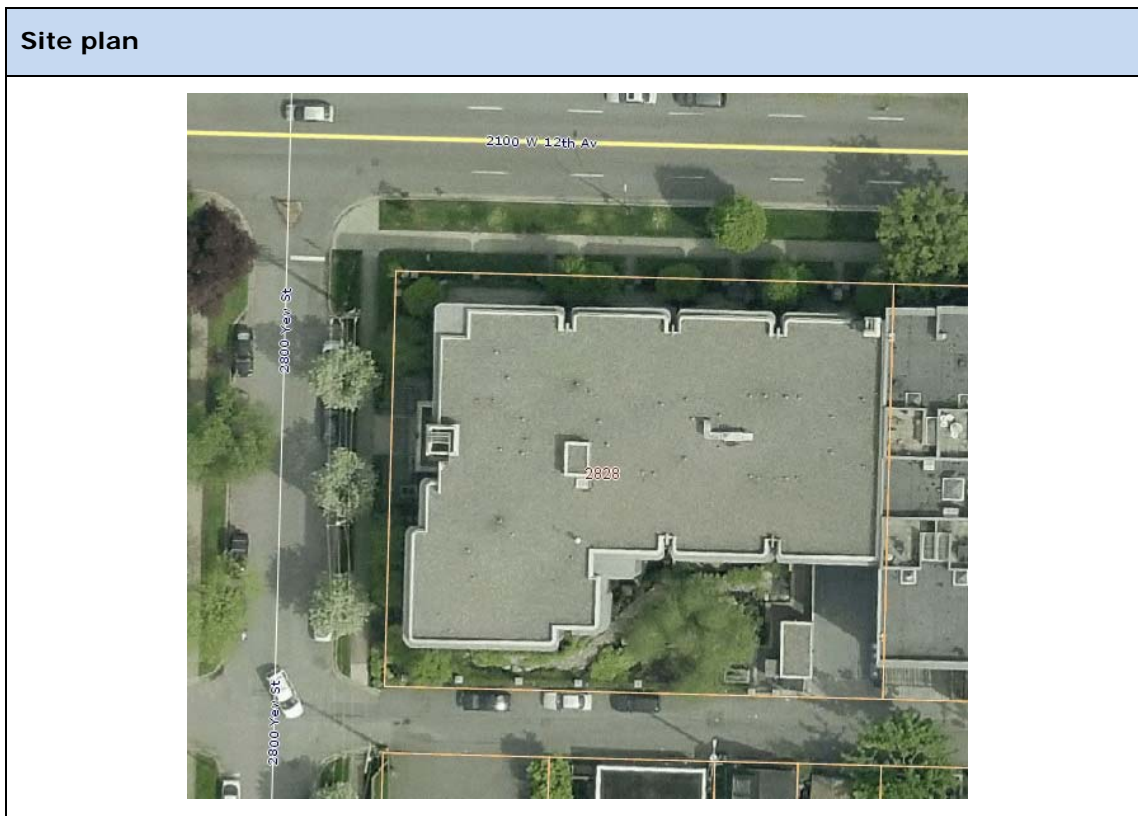
The Strata, constructed circa 2005, consists of thirty-five (35) suites, concrete underground parkade, and various site improvements.
