2-Year Warranty Review Report - DRAFT

District Crossing, 1673, 1677 and 1679 Lloyd Avenue, North Vancouver, BC

PROJECT # 6064.10

DATE July 10, 2013

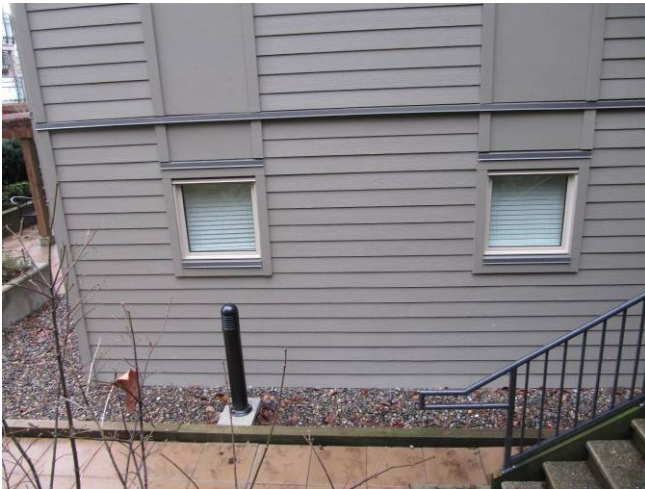
While the current conditions of these assemblies cannot be verified, we observed some water leakage into the parkade at the exterior walls. However, we note that it is not uncommon for below grade parkades to experience some water ingress.

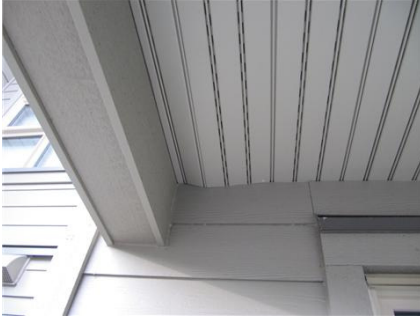
WR 001

Vinyl soffit panel bent out of place.
