# District Crossing Mechanical and Electrical Warranty Review

Prepared for: RDH Building Engineering Ltd  
[www.rdhbe.com](http://www.rdhbe.com)  
Vancouver, BC

Prepared by: Besant and Associates Engineers Ltd  
[besanteng.ca](http://besanteng.ca)  
tel: 604 990-1751 & fax: 604 689-4690

Date: 12 July 2013 (draft)

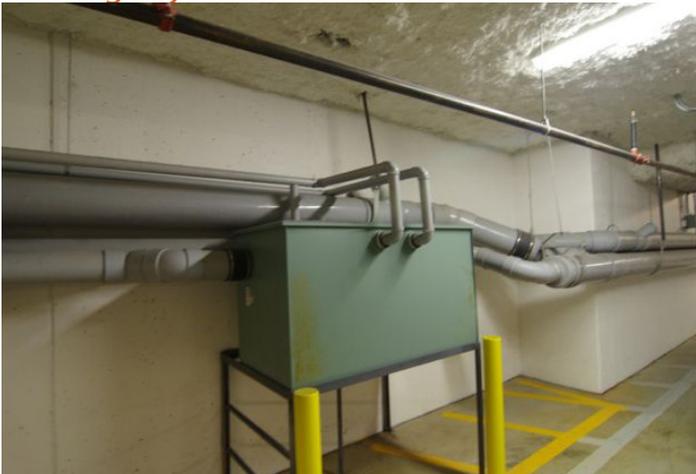
*Photo 5.4— Interceptor on storm drainage system in parking garage*

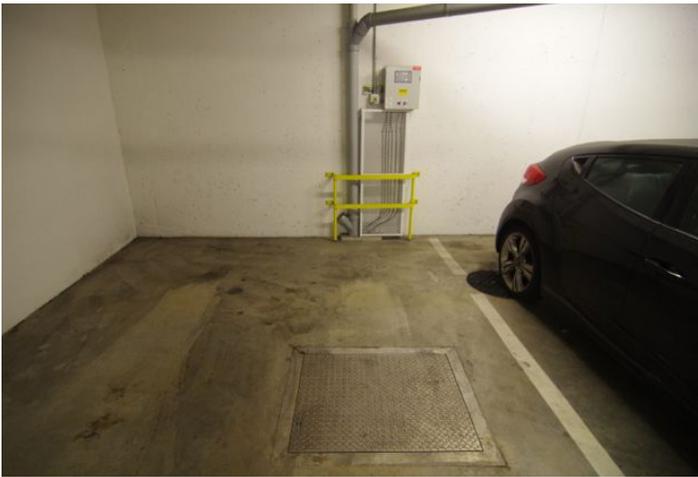
Photo 5.5— Sump pump controller for storm drainage sump pumps

We noted that there are three sump pumps with sump pump controllers by Northwest Tech-Con Systems Ltd. for the drainage system. The controllers are mounted in the parking garage (2 x 1-1/2 horsepower pumps for the storm drainage system and 1 x 1-1/2 horsepower sump for the sanitary drainage system). The pumps are located in confined space so we could not inspect them.

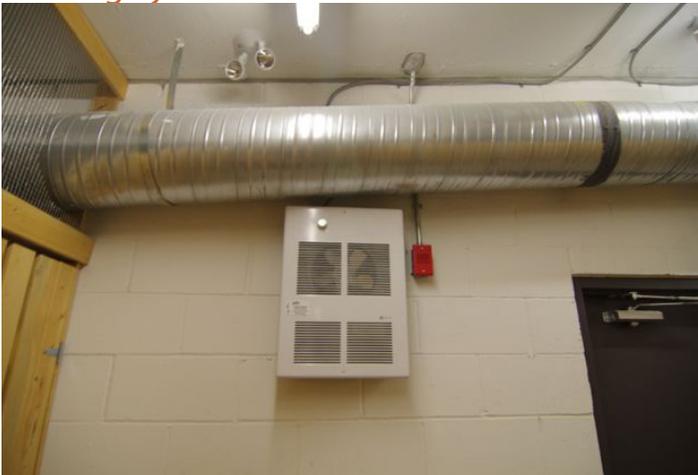
Photo 5.6— Force flow unit heater in storage room

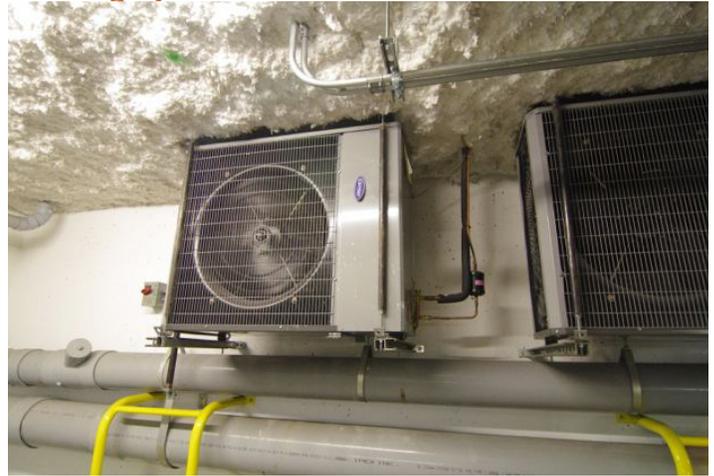
Photo 5.7— An air cooled condensing unit in parking garage serving the commercial units. The hot gas and liquid lines run across the ceiling of the parking garage to the fan coil units.

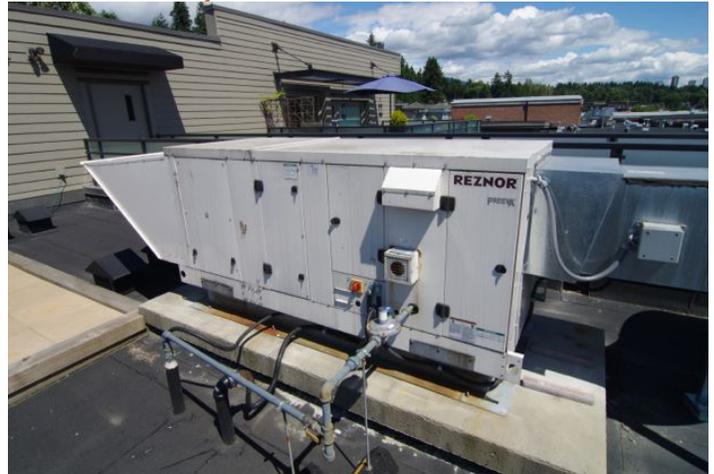
Photo 5.8— Roof mounted make-up air unit.

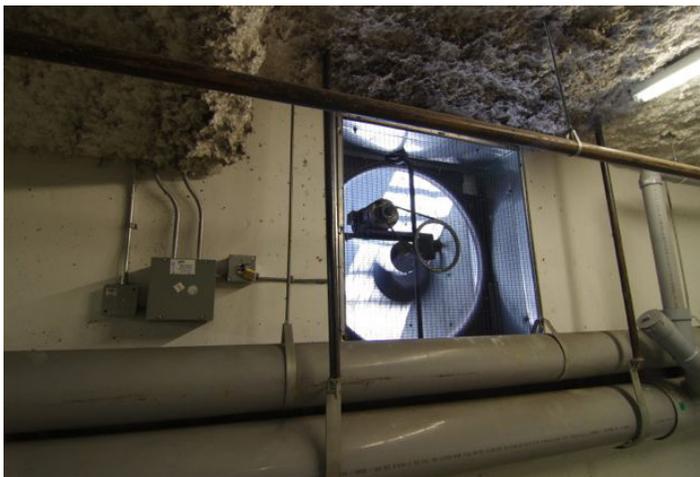
Photo 5.9—Sidewall exhaust fan in parking garage.

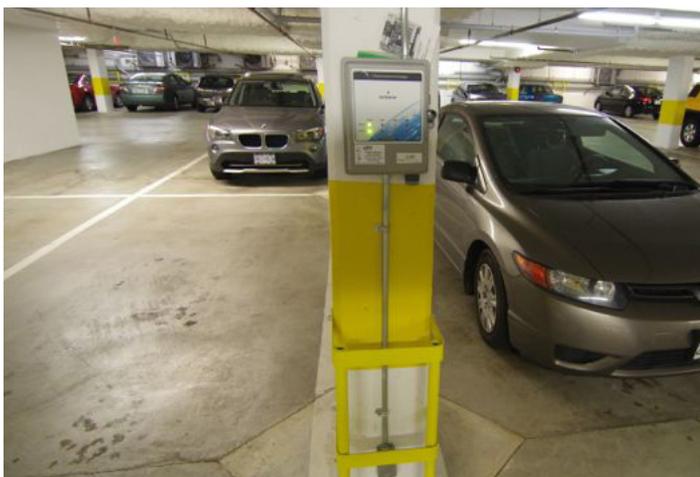
Photo 5.10— Gas detection system mounted on column in parking garage.

The fans in the parking garage are controlled by a gas detection system. All of the equipment appeared functional and properly installed.

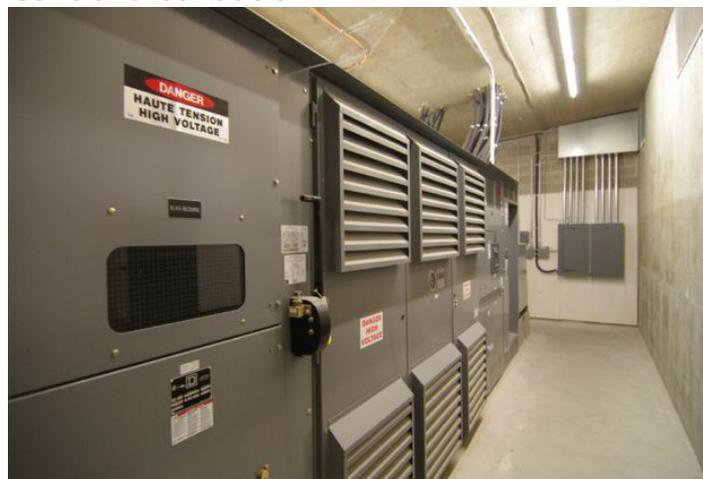
Photo 6.1— Load break switch, main transformer and Central Distribution Panel in electrical room.

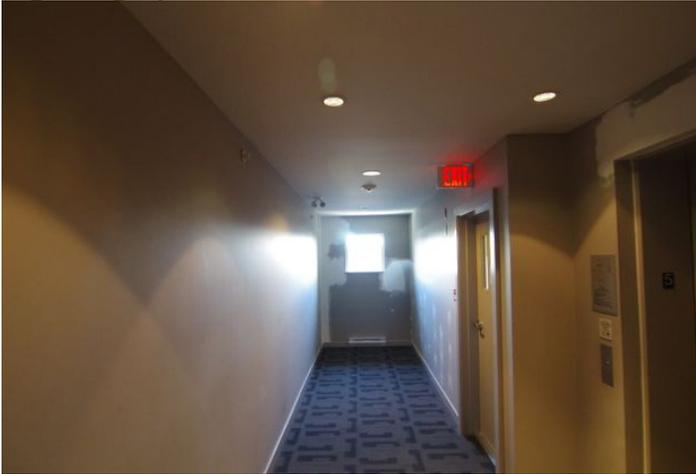
Photo 6.2— Hallway lights in interior of residential building (compact fluorescent pot lights) and MR-16 pot lights.

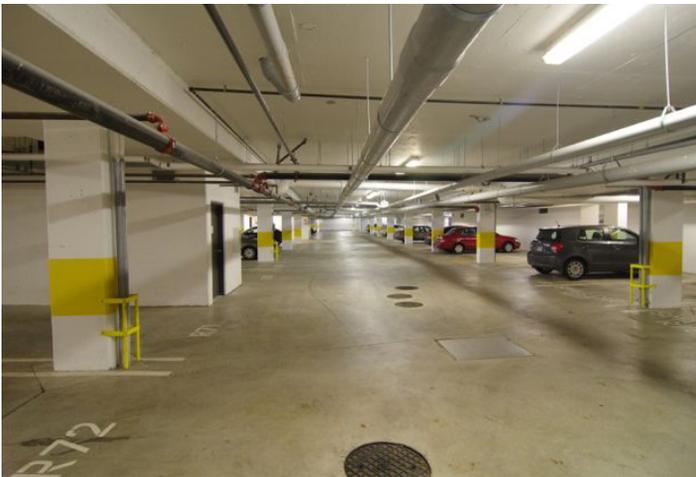
Photo 6.3— Surface mounted T-8 lightings in parking garage.

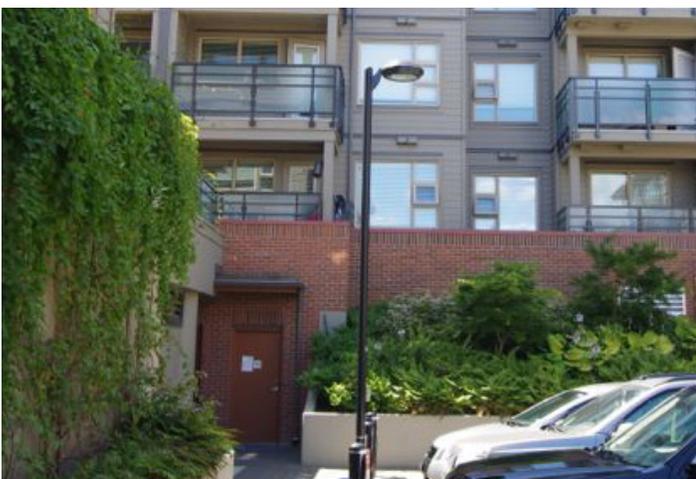
Photo 6.4— Decorative pole mounted light fixture in parking area.

The owners should be aware the LED lighting systems are becoming more economical and more commonplace. Consideration should be given to looking at retrofit options over next few years.

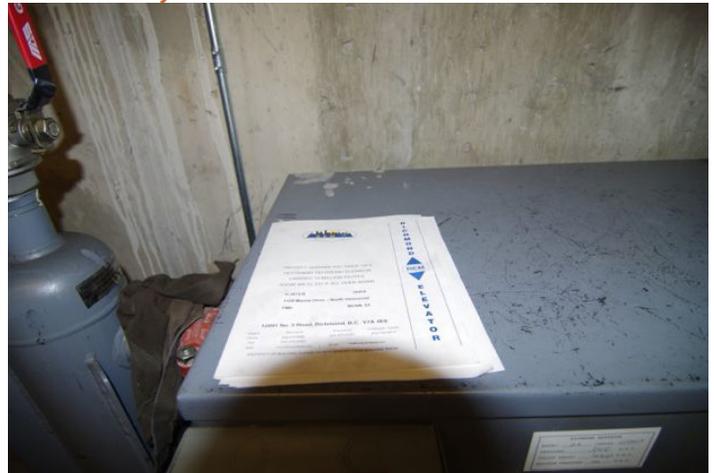
Photo 6.5— Photo shows the hydraulic pump for an elevator.

There is a service contract in place for the elevator system. The log book showed that the elevators were working properly.

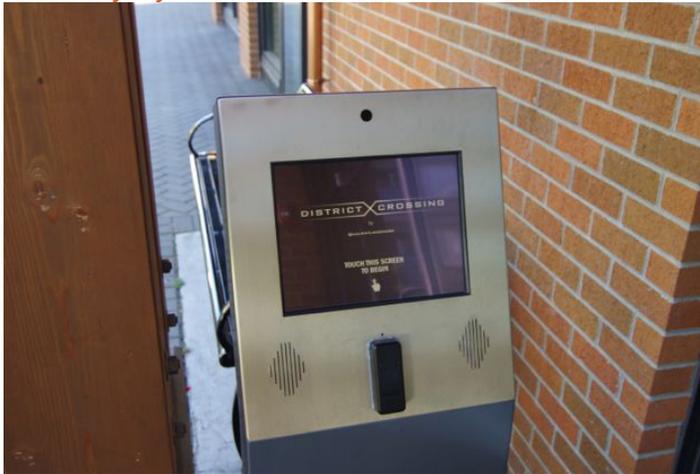
Photo 6.6— Security Panel in main communication room

Since this is electronic equipment a visual review does not reveal much about the operation of the equipment. We noted that hardware was properly installed and free of physical damage.

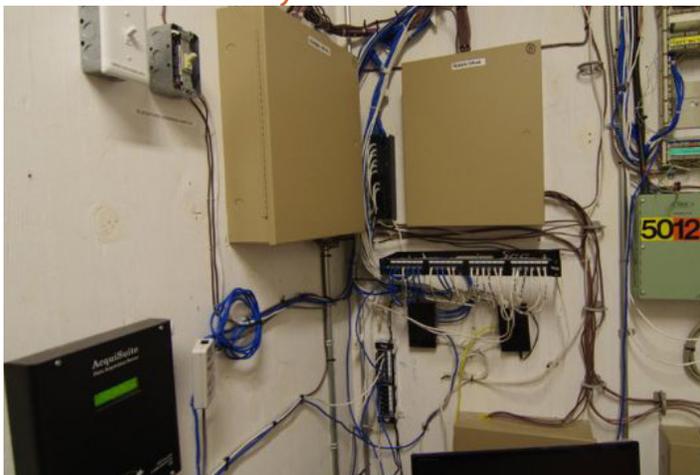
Photo 6.7— Fibre optic demarcation cabinet and cable systems

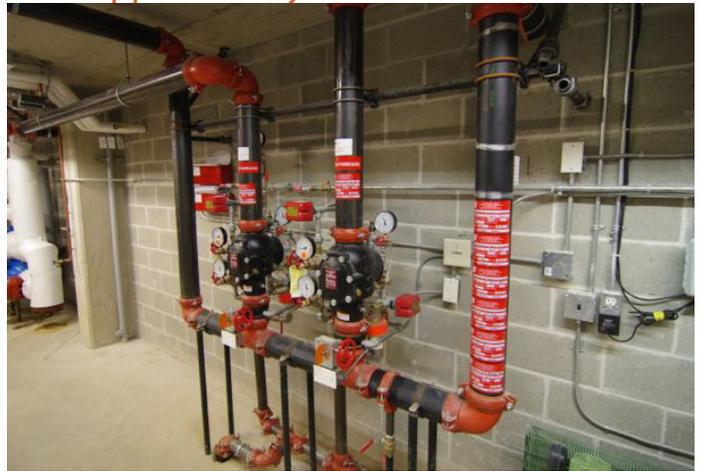
Photo 7.1— Dry valve and flow switch on fire suppression system

No operational problems were noted or reported.

All of the valves had up to date inspection tags, the piping was properly supported and the sprinkler heads reviewed for this report were properly installed. There were spare heads available in the service room.

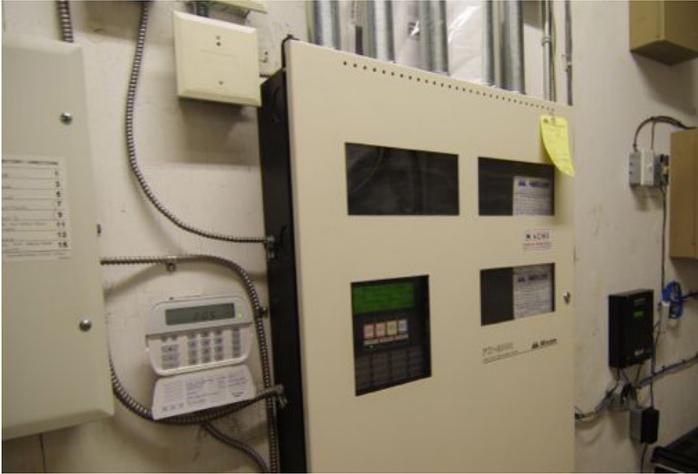
*Photo 7.2-- Main Fire Alarm Control Panel in Communication Room*

We noted that the equipment was properly installed and free of physical damage.
